## METAL / NONMETAL Serious Injury Accident

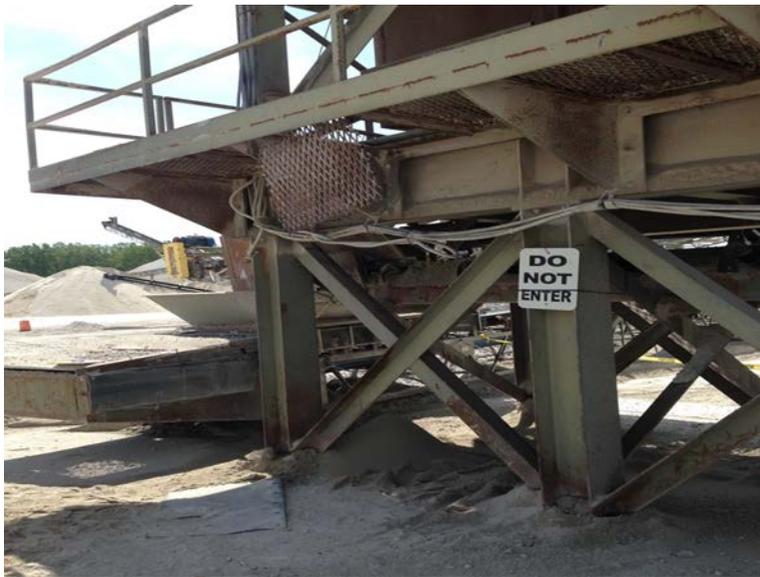
Surface Crushed Limestone – A miner was seriously injured when the expanded metal walkway he was standing on suddenly failed. The miner fell 10 feet directly to the ground below. The expanded metal walkway was covered with conveyor belt to aid in shoveling spillage. The conveyor belt allowed corrosive material to accumulate and accelerated the deterioration of the expanded metal. Further, the application of the conveyor belt masked the signs of deterioration on the walkway, making a thorough workplace examination difficult.

- Examine your work places for all possible hazards and correct them before you perform work.
- Conduct structural inspections periodically.
- Look, listen & feel for abnormalities in walkways.
- Routinely examine metal structures for indications of weakened structural soundness (corrosion, fatigue cracks, bent/buckling beams, braces or columns, loose/missing connectors, broken welds, etc.).
- Keep corrosive material spillage/build-up removed from metal structures.
- Report all areas where indications of structural weakness are found.
