METAL / NONMETAL

Near Miss Accident

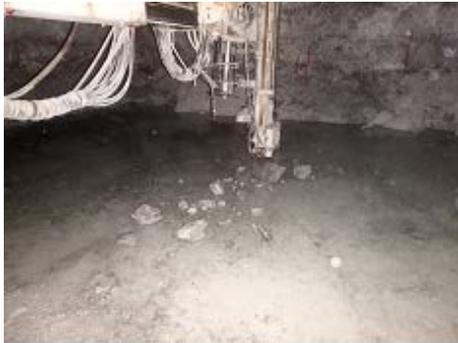
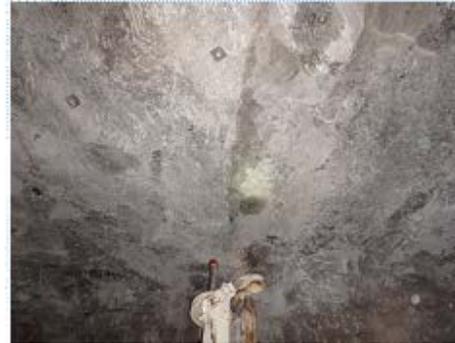
Underground Lime Stone Mine – April 2015 – A roof-bolter operator was working under supported back/roof, when the victim was struck by a piece of falling roof that measured 3 foot by 1 foot and varied in thickness up to 3 inches. The miner was transported to the hospital and he was treated for his injuries.

- Examine and test ground conditions prior to performing work.
- Take down or support ground that creates a hazard to persons before performing other work or travel in the affected area.
- Train miners in safe work procedures and hazard recognition, specifically when bolting.
- Design, install, and maintain a supplemental support system to control ground where additional support is necessary.
- Promptly initiate action to install additional support when adverse ground conditions are identified.
