## Coal Mine Fatal Accident 2005-19

Operator:	Rosebud Mining Company
Mine:	Logansport Mine
Accident Date:	December 12, 2005
Classification:	Roof Fall
Location:	Dist. 2, Armstrong County, PA
Mine Type:	Underground Coal Mine
Production	2,500 tons/day

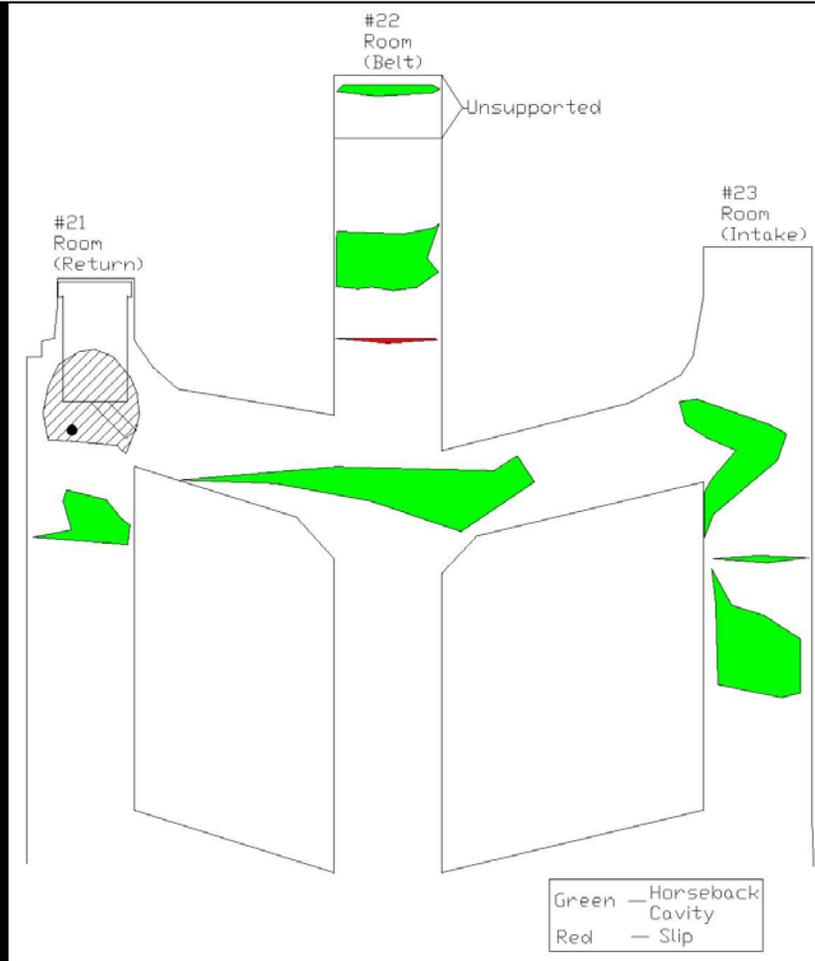
The victim was the continuous-mining machine (continuous miner) operator. He mined a total of six cuts in the Nos. 21, 22, and 23 rooms during the shift. At approximately 1:30 p.m., he moved the continuous miner with attached mobile bridge conveyor through the last open crosscut from No. 22 to No. 21 room to complete an intersection and advance the No. 21 room.

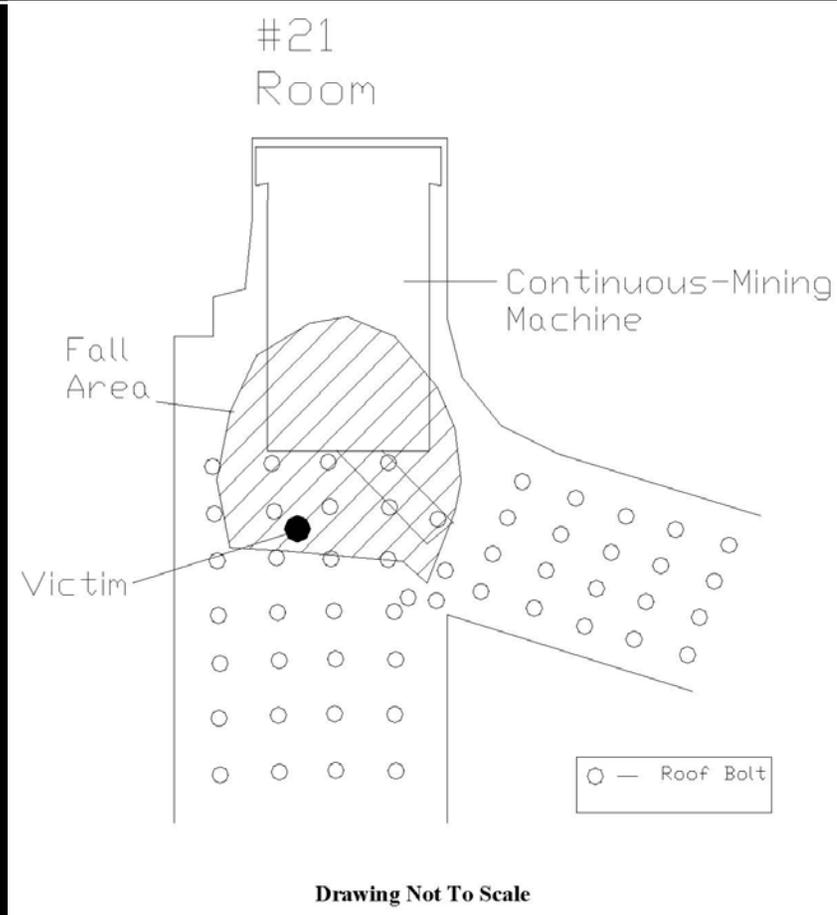
He was positioned in the crosscut on the right side of the continuous-mining machine while mining the intersection. He moved to the left side of the continuous miner, just outby the second row of permanent roof supports, in the intersection, to advance the face. The curtain-side lift was mined approximately 30 feet inby the last row of permanent roof supports when the roof fall occurred.

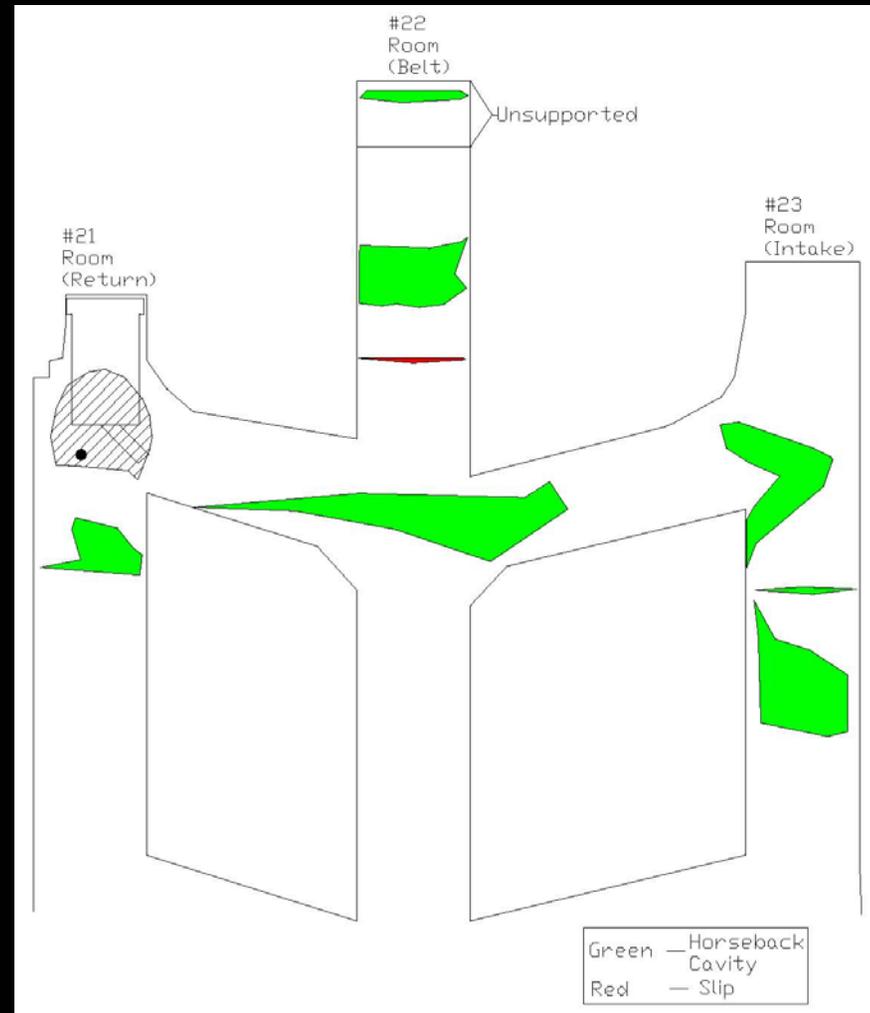
An Eimco Dash-Zero continuous-mining machine, and a single mobile bridge unit with two bridge carriers, were being used during panel development. Rooms and crosscuts were driven a maximum of 20 feet wide with room centers of 52 feet and crosscut centers of 55 feet (on 60° angles).

The approved roof control plan permits cuts to a maximum depth of 40 feet in normal roof conditions. When subnormal or adverse roof conditions are encountered, the depth of the cut will be limited to 20 feet or less. A cut of approximately 30 feet was mined in the No. 21 return entry.

Corrective Action: Changes have been implemented to clarify and improve the effectiveness of the roof control plan. The roof control plan was reviewed and explained to all employees prior to mining being resumed. To verify roof conditions, a test hole 24 inches longer than the bolt or rod being used but at least 6 feet in length shall be drilled in the first row of bolts in each cut, the approximate center of intersections, and in visibly defective roof. If bed separation is detected a roof bolt that will anchor at least 18 inches above the separation will be used.

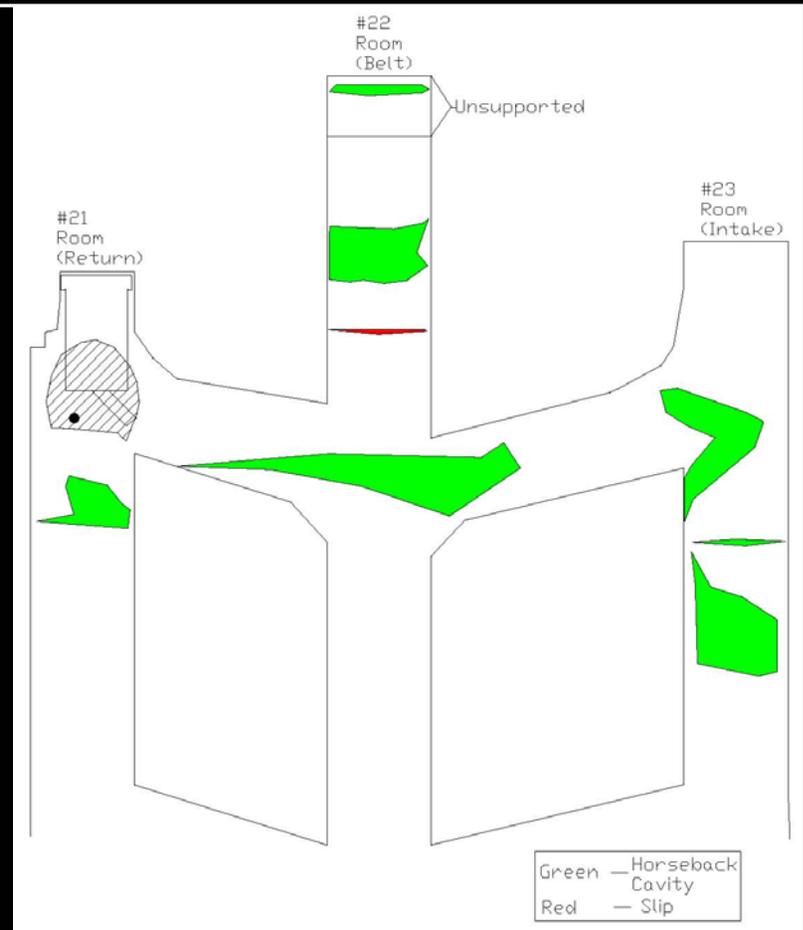
In the general vicinity of the accident site, several prominent geologic features were observed in the roof and ribs. Rock wedges, typically referred to as "horsebacks" or "drag folds" had fallen in all three rooms. Slickensided fault surfaces that bound these wedges were apparent in the fall cavities. Slickensided planes commonly referred to as "slips" were also present. These features are characterized as single planes that are inclined into the roof without forming wedges. A thin calcite layer was observed on many of the exposed slickensided surfaces; this layer appeared as a thin white line in some areas where it intersected the immediate roof surface. A horseback (drag fold) had previously fallen out of the mine roof in the return entry approximately 12 feet outby the edge of the intersection roof fall area.

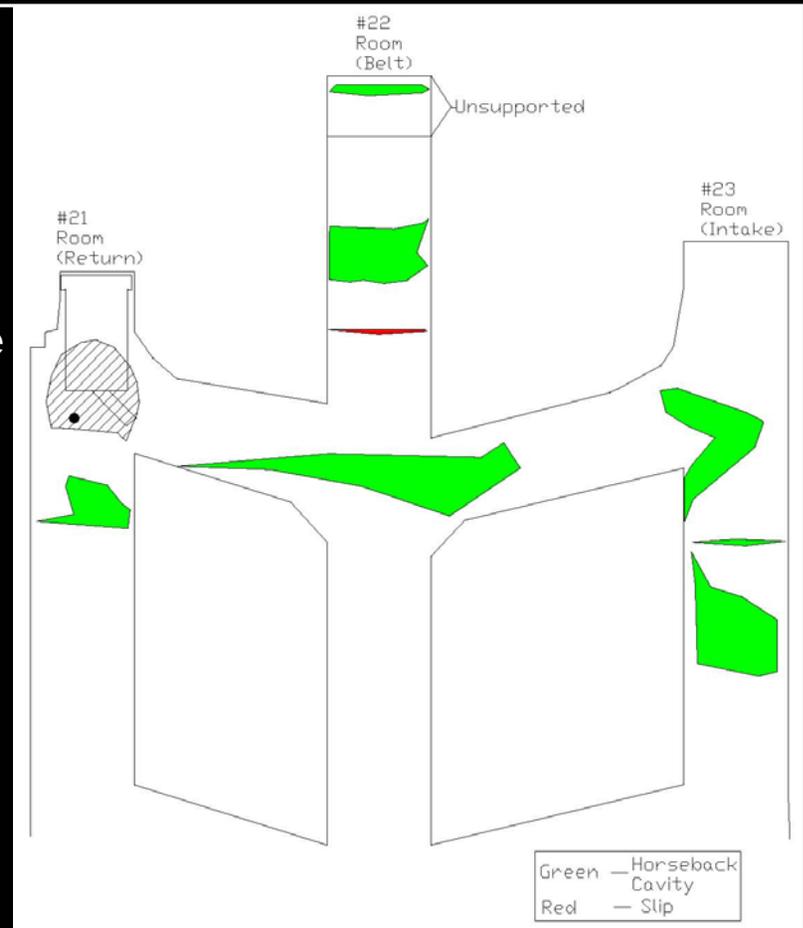
The majority of the slickensided faults on the section are oriented along a trend of approximately N30°E, while a second set is oriented nearly perpendicularly to the first, along a trend of approximately N50°W. The N30°E faults are arranged to define two nearly parallel zones, separated by a distance of approximately 30 feet, that trend N30°E across the 6th North Butt. The outby fault zone projects directly into the intersection where the fatal roof fall occurred.

The fallen material remained largely intact and was estimated to weigh 20 tons.

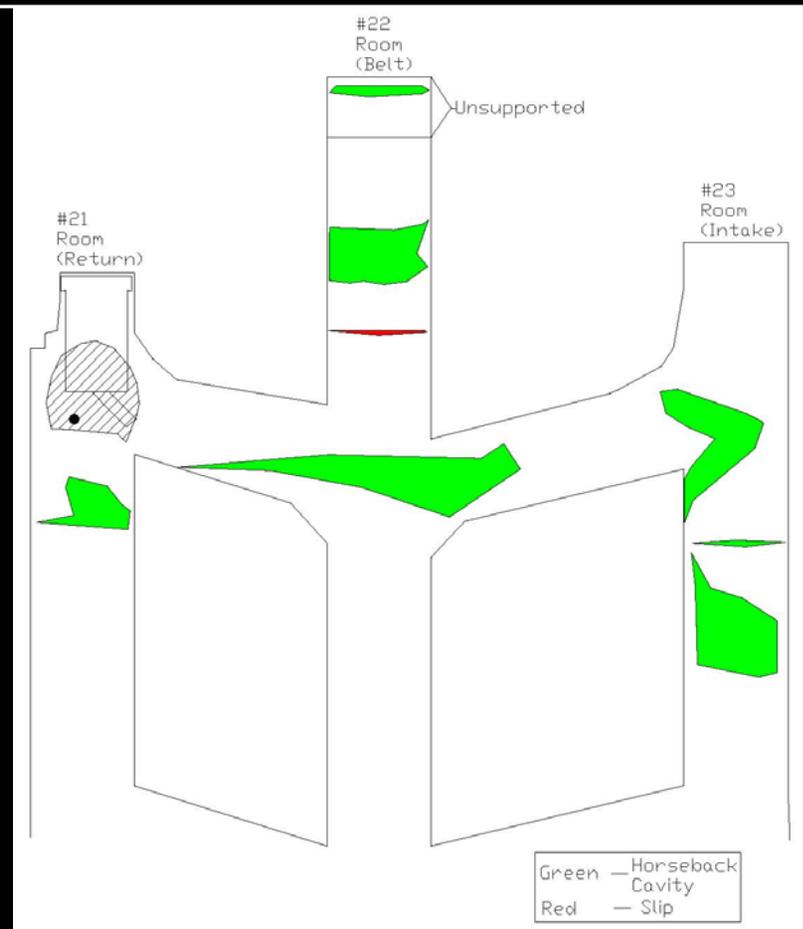
Approximately 12 feet outby the edge of the intersection fall cavity, a horseback (drag fold) had been encountered in a previous cut from the No. 21 room. This feature had formed a linear wedge-shaped cavity approximately two feet wide by 1 ½ feet high, and projected into the rib where the fall-bounding N50°W-striking fault cut into the coal pillar. This drag fold zone represents the expression in the roof of the normal fault that controlled the intersection fall.

There were numerous locations in the mine roof where horsebacks had fallen out during mining, leaving cavities up to 48 inches above the normal height of the mine roof. This should indicate to mine management that a roof bolt length greater than 42 inches would be needed to anchor in solid strata to adequately support the roof.

Corrective Action: Changes have been implemented to clarify and improve the effectiveness of the roof control plan. A minimum length roof bolt of 6 feet will be used in areas of subnormal roof beginning 8 feet outby in good roof and extending 8 feet past into solid roof.

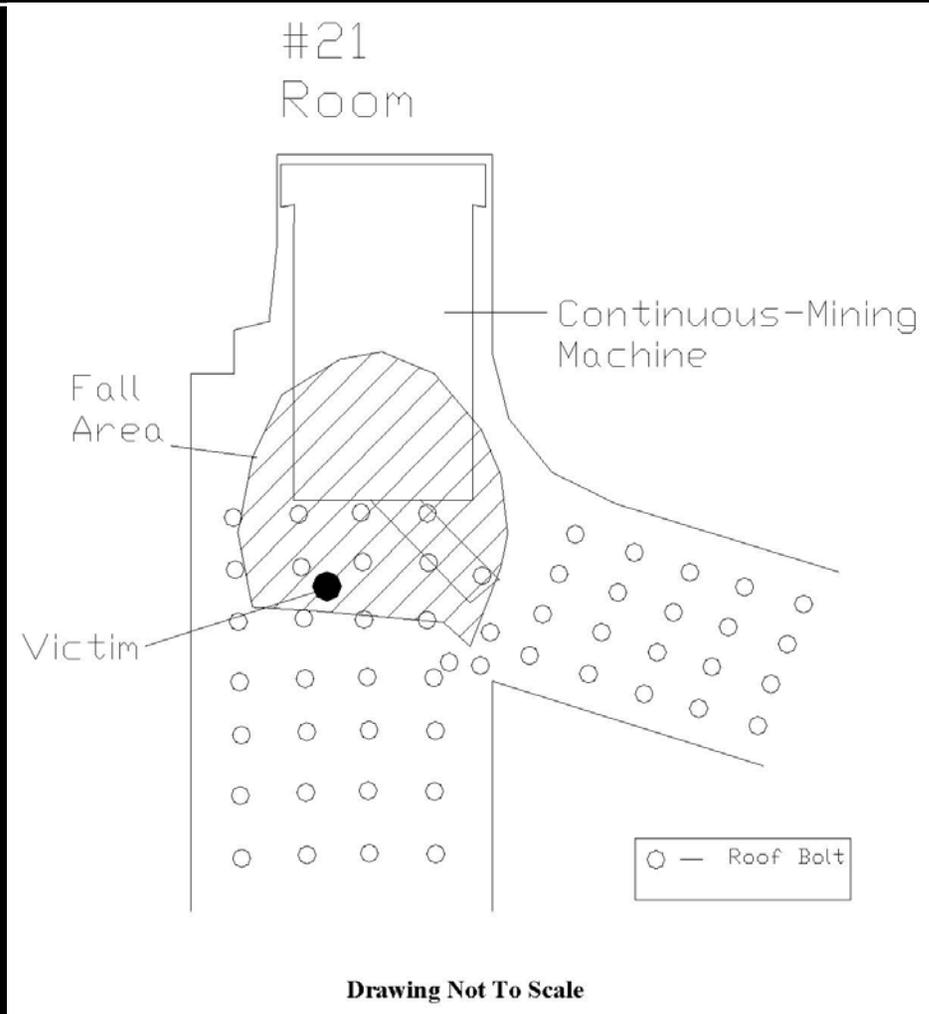
The roof at the accident site where the fall occurred was bolted exclusively with 36 inch and 42 inch fully grouted roof bolts.
