REPORT OF INVESTIGATION

**Fatal Powered Haulage Accident
November 16, 2007**

**Rock Island Mine
Farrell-Cooper Mining Company
Rock Island, Le Flore County, Oklahoma
ID No. 34-01648**

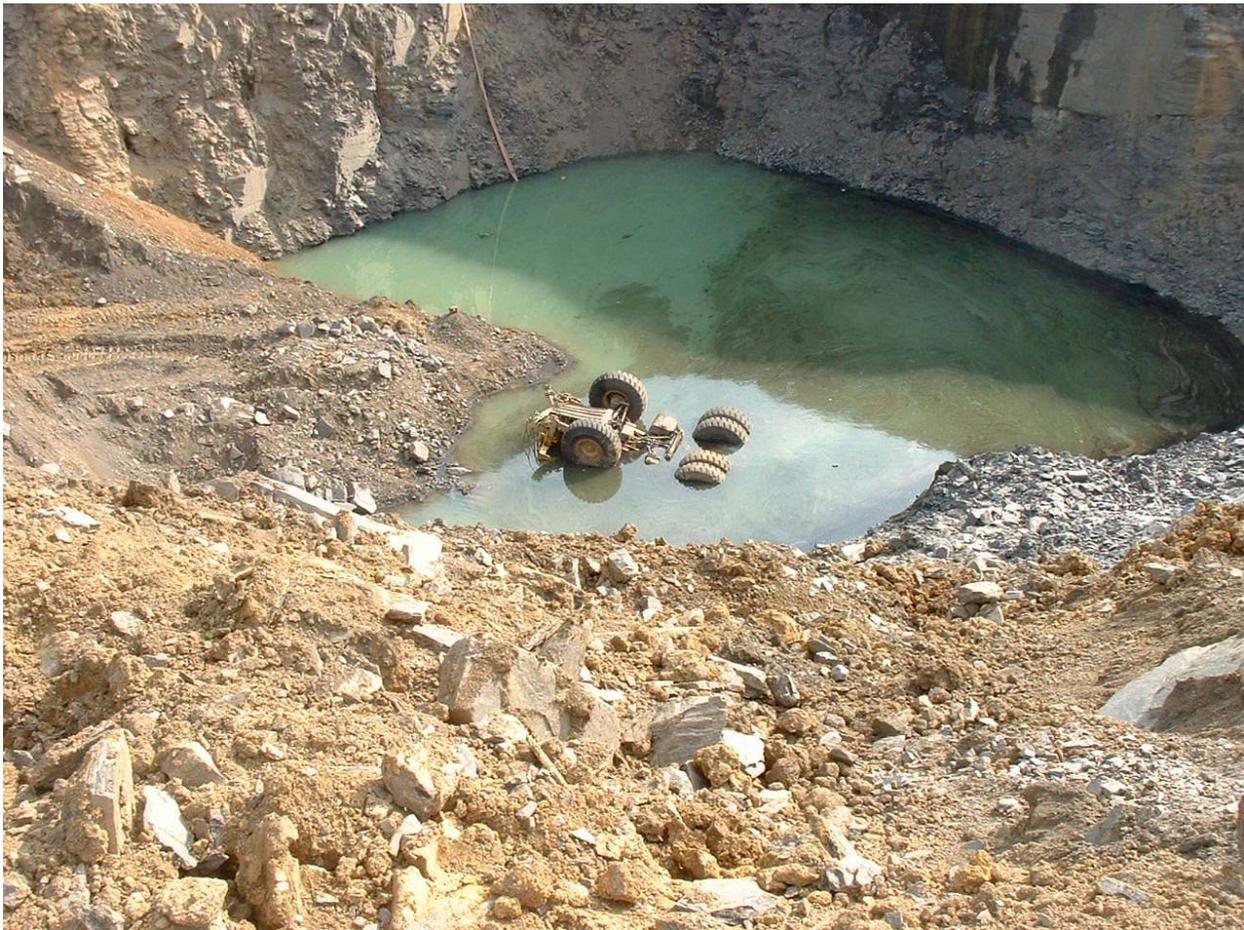
VIEW OF TRUCK FROM POINT OF OVER-TRAVEL
177 FEET ALONG SLOPE FROM TOP OF DUMP TO TRUCK

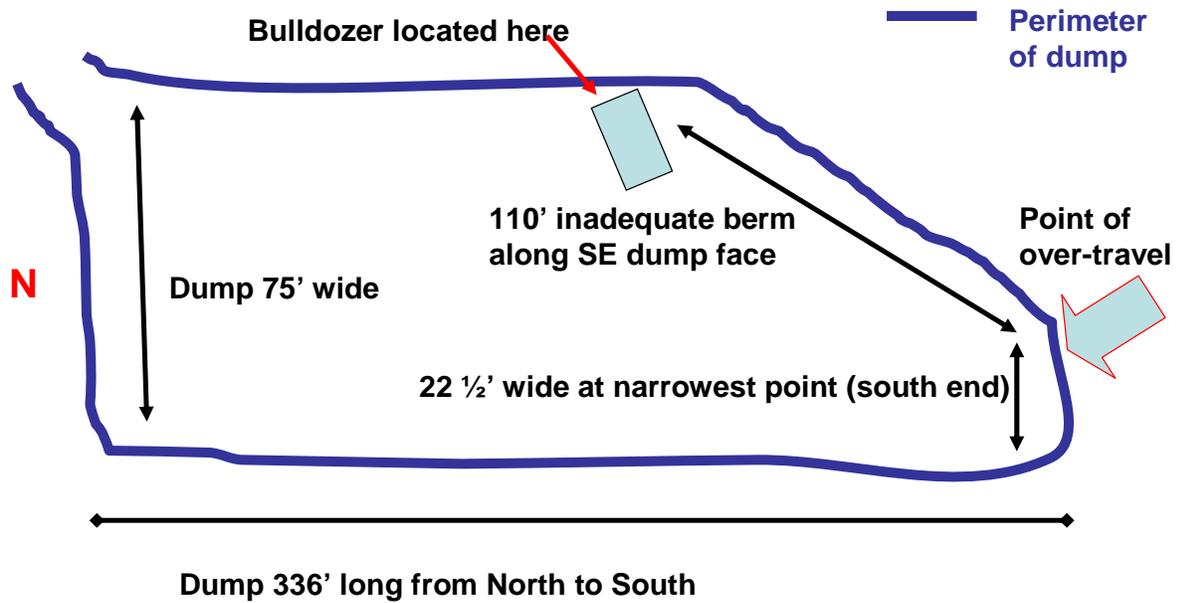
Dump Information: The dump was approximately 336 feet long on the western edge, 75 feet wide at the widest point, and 22.5 feet wide at the point of over-travel. The southeast edge was 110 feet long and did not have adequate berms in place for the entire distance. The dump was flat and level and the weather was dry at the time of the accident. Refer to Appendix B for a sketch with dimensions of the dump.

West Pit Spoil Dump Measurements

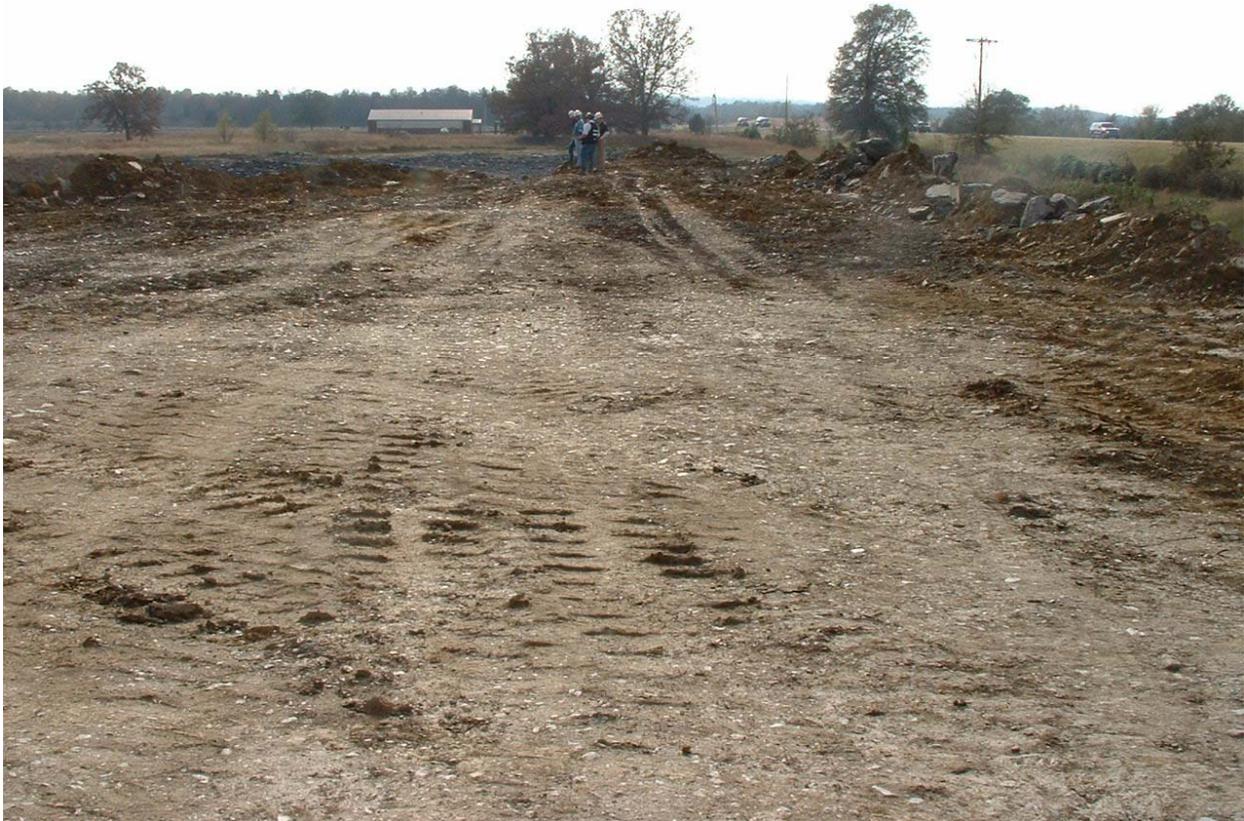
Appendix C

View of Dump from North Persons Standing Near Point of Over-Travel Tire Marks from Truck Visible on Dump Surface

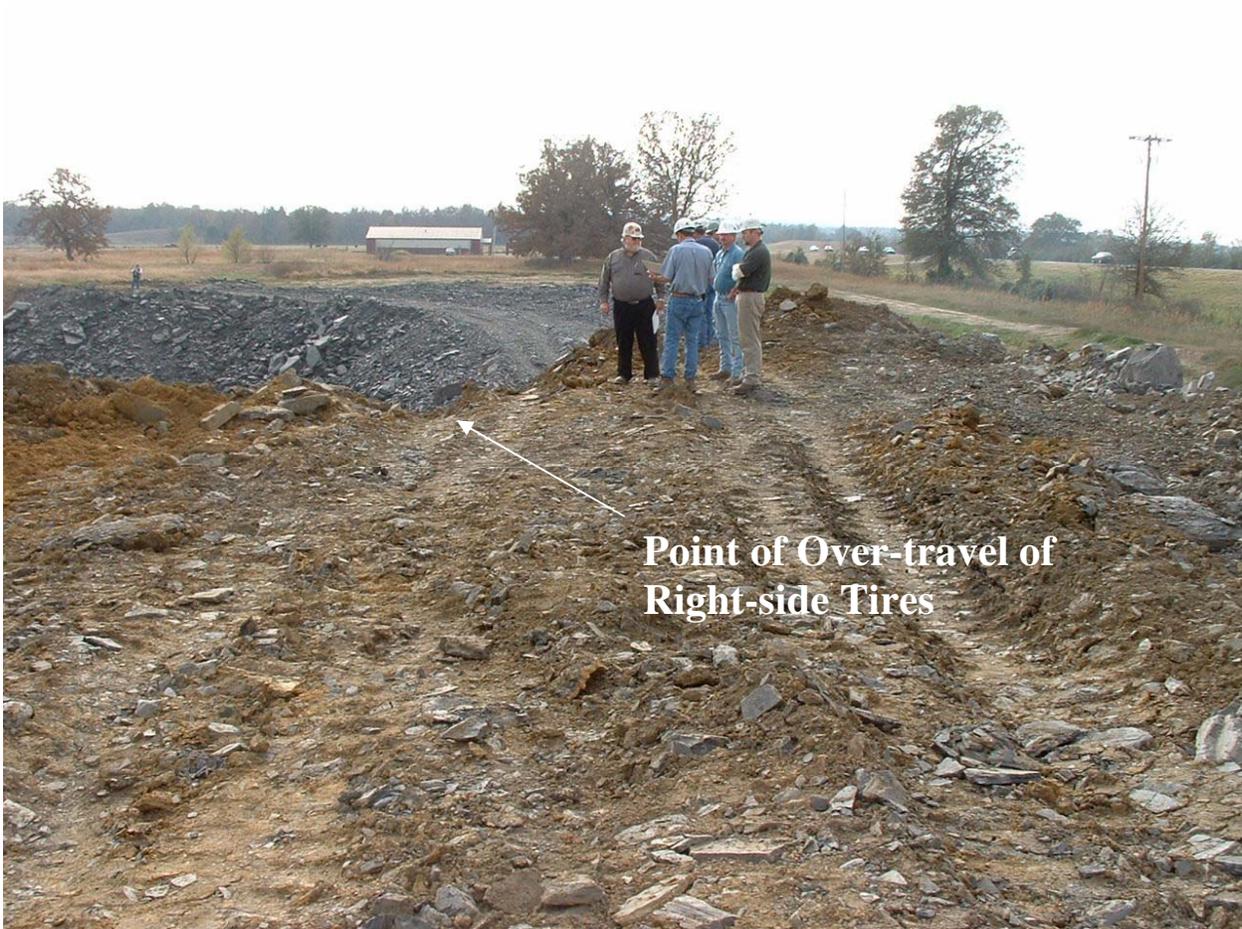
Appendix D

4. A 104(d)(1) order, number 7610684 was issued to Farrell-Cooper Mining Company for a violation of 30 CFR 77.1605(l). Berms, bumper blocks, safety hooks, or similar means were not provided to prevent over travel and overturning at the West Pit spoil dump. On November 16, 2007 at 20:48, a Caterpillar 775E haul truck (company number 1055) over

traveled and overturned causing fatal injuries to the operator of the truck. No berms, bumper blocks, safety hooks, or similar means were present along the southeast side of the dump for the entire 110 feet in length. The mine experienced a reportable accident on October 30, 2007, due to a similar circumstance, citation 7285259 was issued for that circumstance and citation 7285258 was issued for another part of the mine during the E01 inspection conducted concurrent with this E06 investigation for this standard. A total of 185 feet of berms were missing at dumping locations throughout the entire mine including the area of the fatal accident. This violation is an unwarrantable failure to comply with a mandatory standard.

Close-up View from North End of Dump at Point of Over-travel Tire Marks Visible on Dump Surface

Corrective Action: Drivers should be trained to back up perpendicular to the edge of the dump and to use properly constructed berms at the edge as guides for stopping and dumping the load. Berms should not be used to help stop the truck and rear tires should not run up on berms so that material can be dumped over the edge.

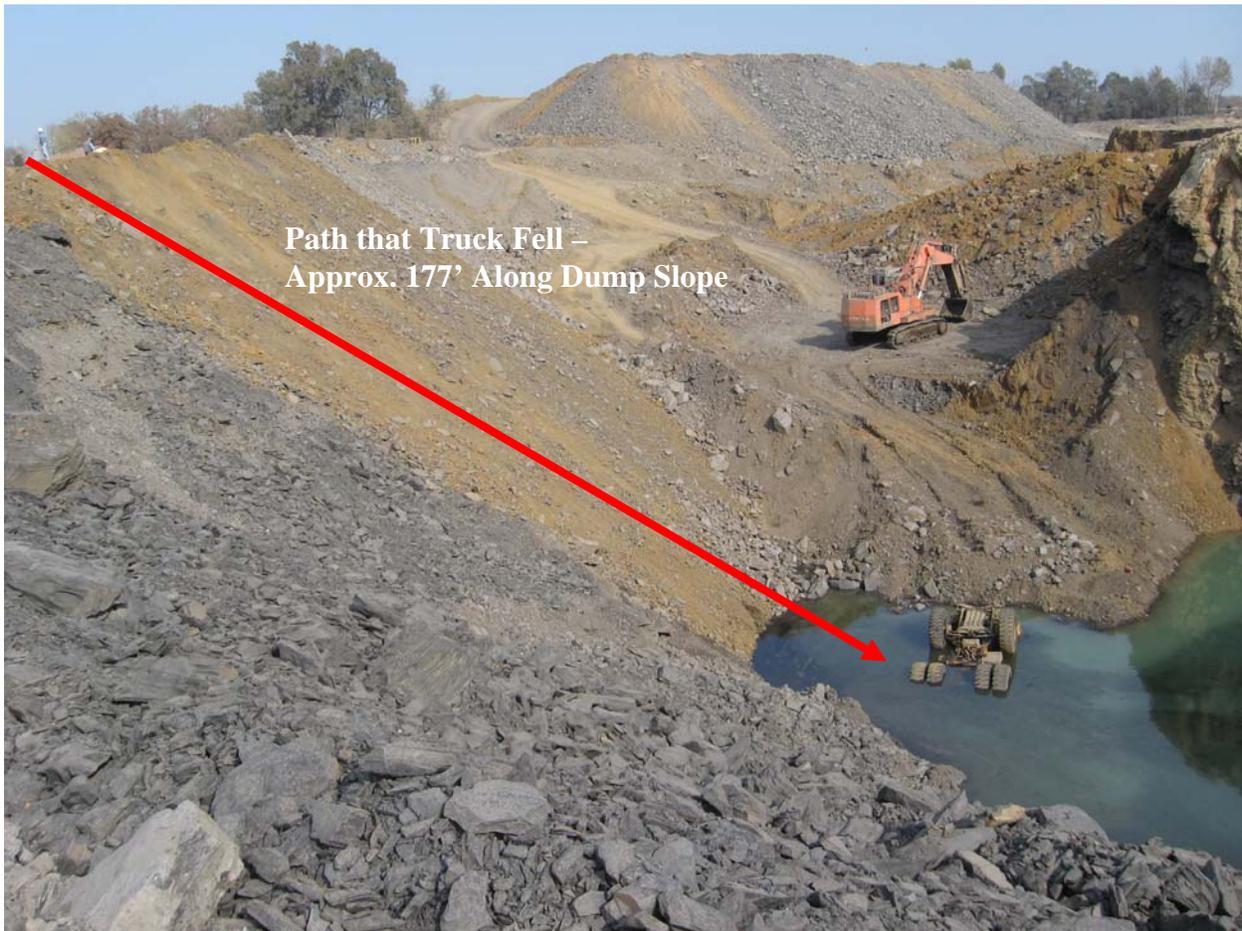
Appendix E

View of Pit with Shovel Located Approximately at Location when Accident Occurred - Path of Truck from Dump to Pit

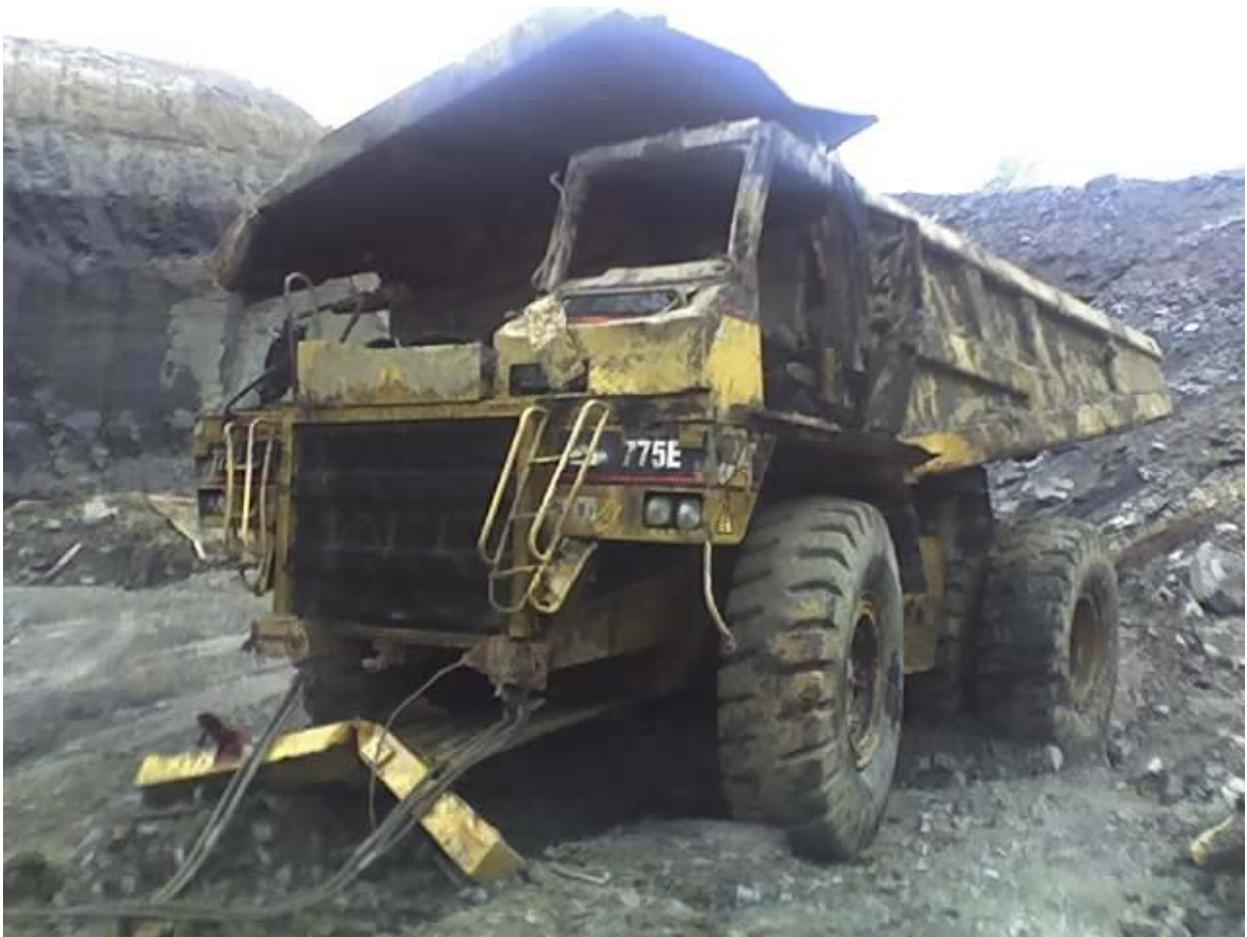
Appendix F

Condition of the Truck: The truck was found on its top as a result of the accident. The right side of the frame was broken behind the rear axle. The front of the bed and top of the Rollover Protective Structure/Falling Object Protective Structure (ROPS/FOPS) were damaged. The hydraulic line for the bed lift on the left side was broken and the cylinder tilted towards the frame. The left and right side mirrors were broken. The ladders and railings on the truck and the

ROPS/FOPS were bent. The fuel cap was missing. The left door was bent. The right rear window was the only one in place; reportedly the windows were cracked out during the move and not from the accident. The operator's compartment contained mud and rocks after removal from the water. The cab was washed to remove the debris. Reportedly, the right side door could not be opened at the accident scene but functioned during the evaluation.

Haul Truck after Removal from Water

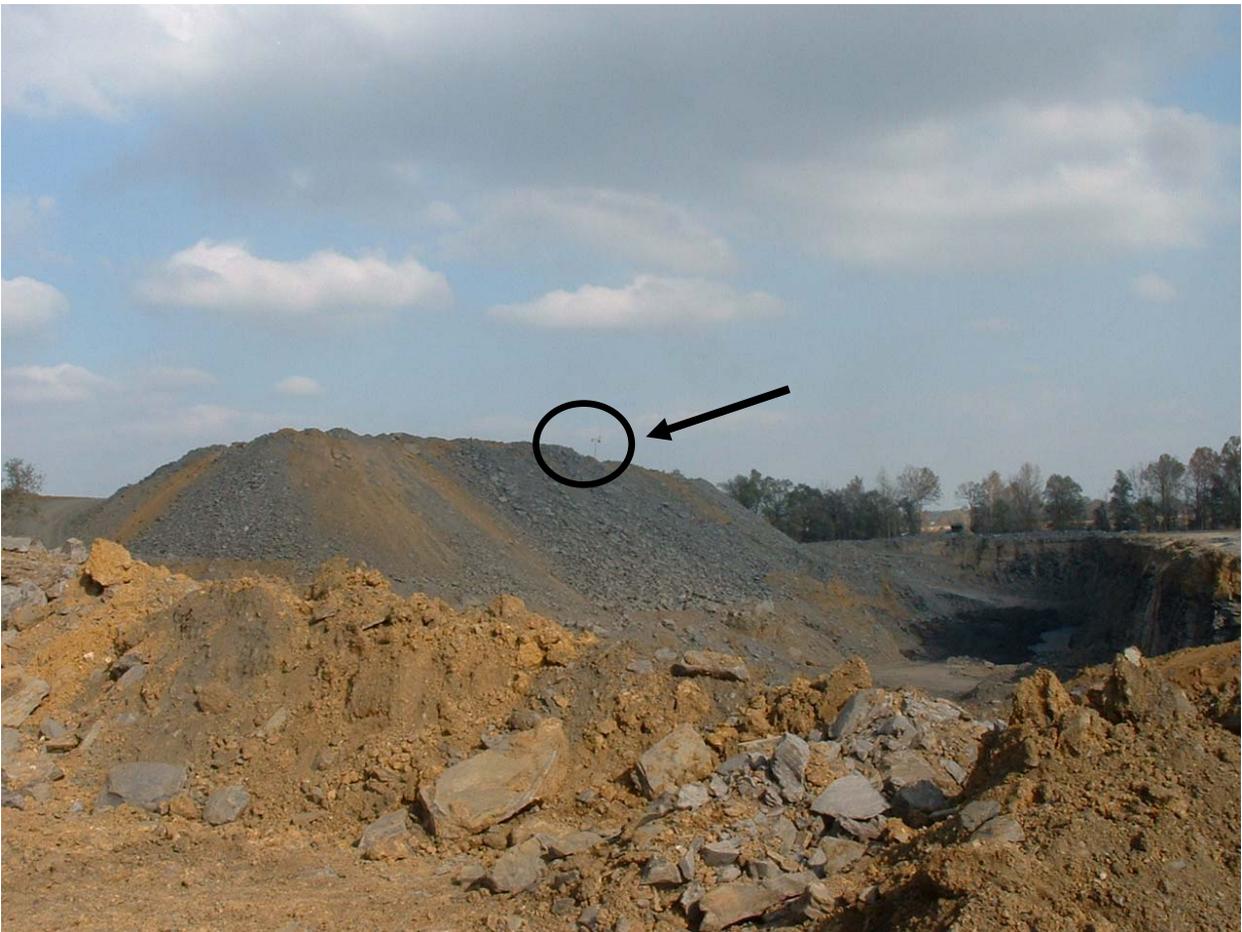
Appendix G

Lighting: Illumination was not sufficient to provide safe working conditions on the West pit overburden dump site. Only the lights from the mobile equipment operating on the dump area were present. The nearest portable light plant was located 900 feet to the east of the dump area. The lights did not supply sufficient illumination; shadows were present along the edge of the southeast side and the south end of the dump site preventing identification of the edges of the dump. This condition contributed to the fatal accident that occurred on November 16, 2007.

**Light Plant Located in Circle
Approximately 900 Feet from
Point of Truck Over-Travel on Dump**

Corrective Action: The mine operator shall require thorough on-shift examinations and have all hazards corrected and documented in the record book.
