REPORT OF INVESTIGATION

Surface Coal Mine

Weston Engineering, Inc. (WT9)

North Antelope Rochelle Mine
Peabody Powder River Mining LLC
Wright, Campbell County, Wyoming
MSHA I.D. No. 48-01353

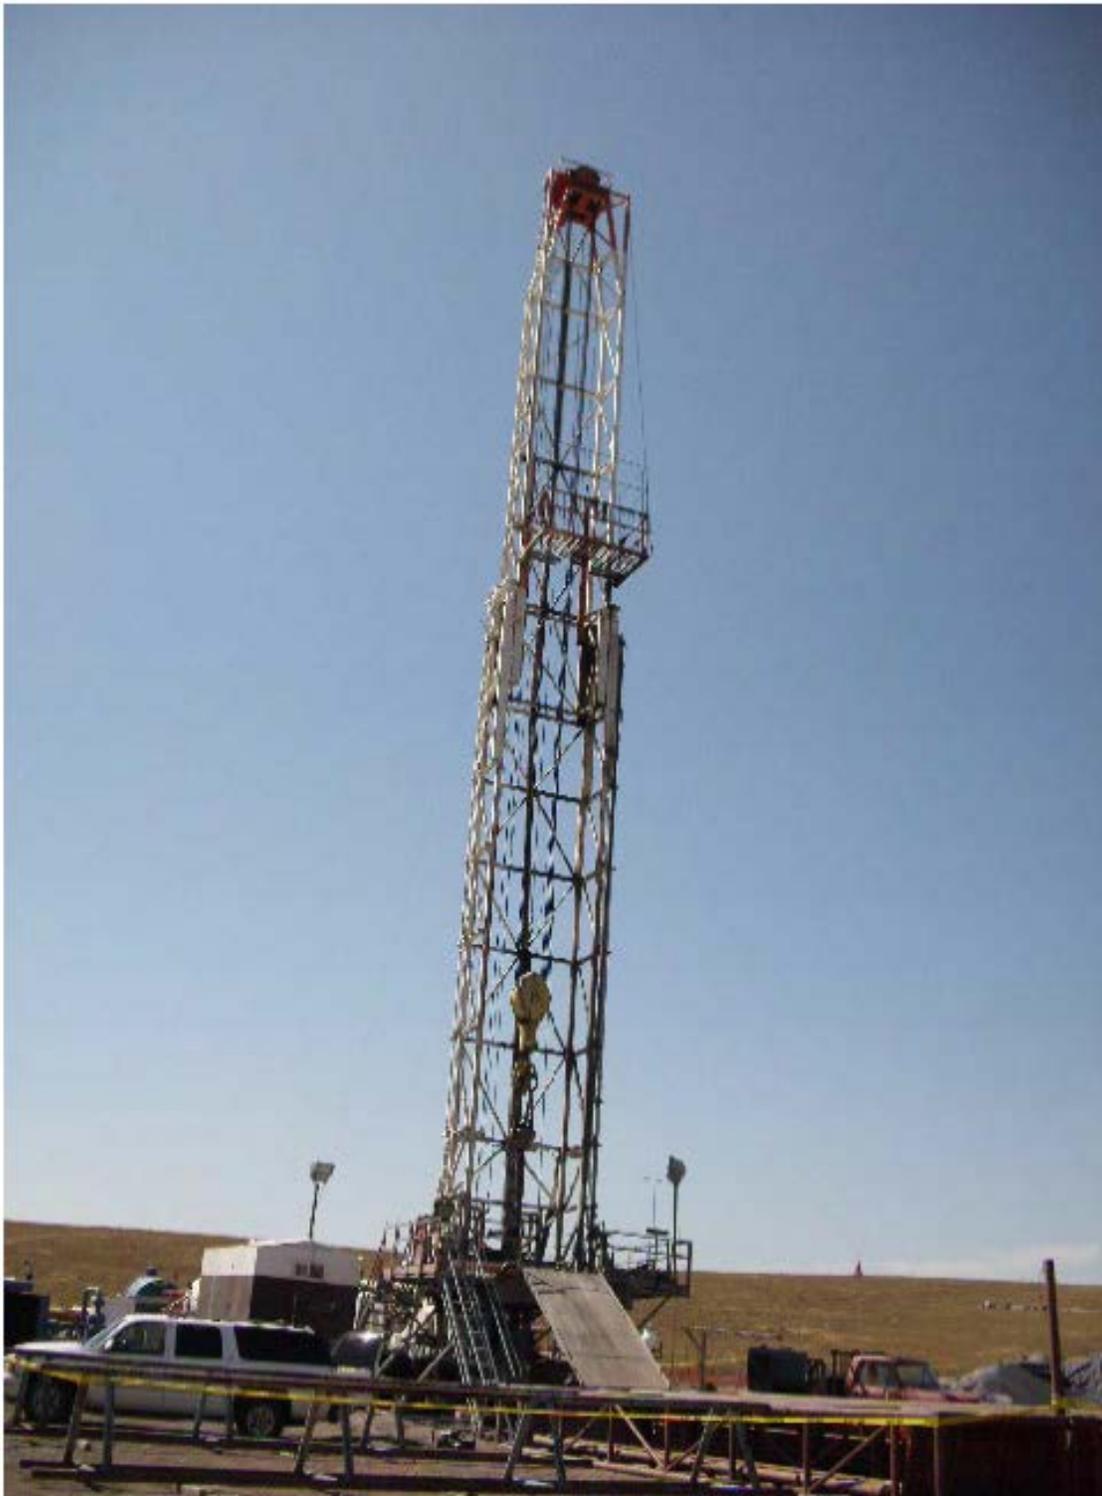
VIEW OF DRILLING RIG ACCIDENT SITE

The accident happened at the Rig #109, Well #26 pad located at the North Antelope Rochelle Mine.

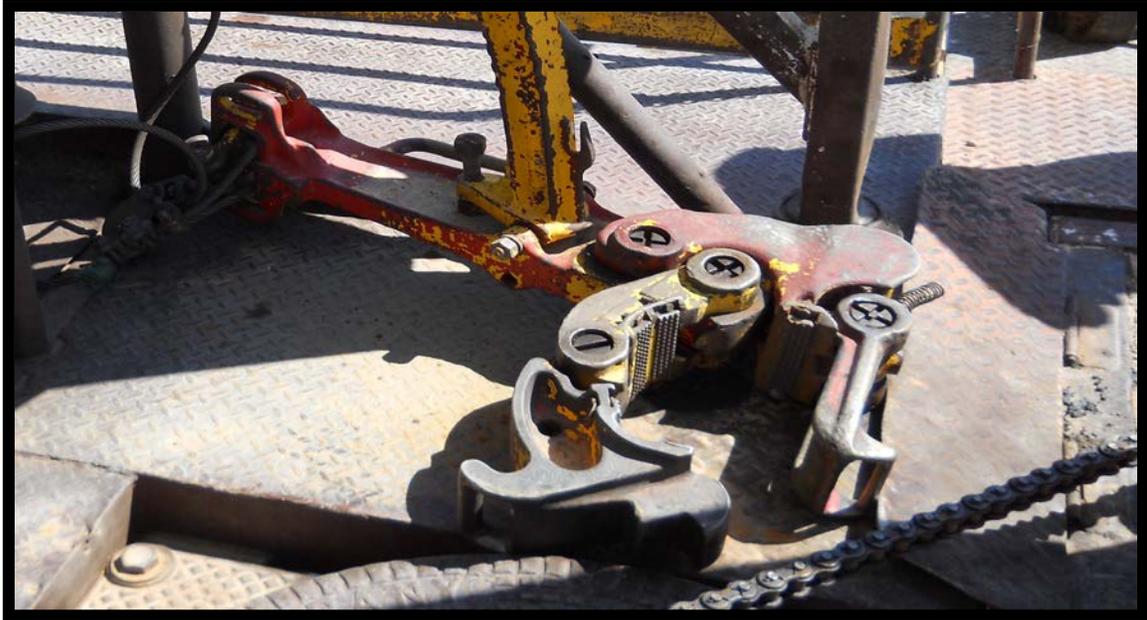
FIGURE 1: Tong Wrench Configuration

the same time, Hunt, seeing the wrench was in place, began to release pressure, applying torque to the drill pipes. The tong wrench began to rotate clockwise, with the release of pressure on the pipe, until the wrench reached the end of the tightening cable, referred to in the drilling industry as the “snub line.” The snub line cable, in this application, is used to prevent the Kelly and drill pipe from turning, thereby maintaining the torque.

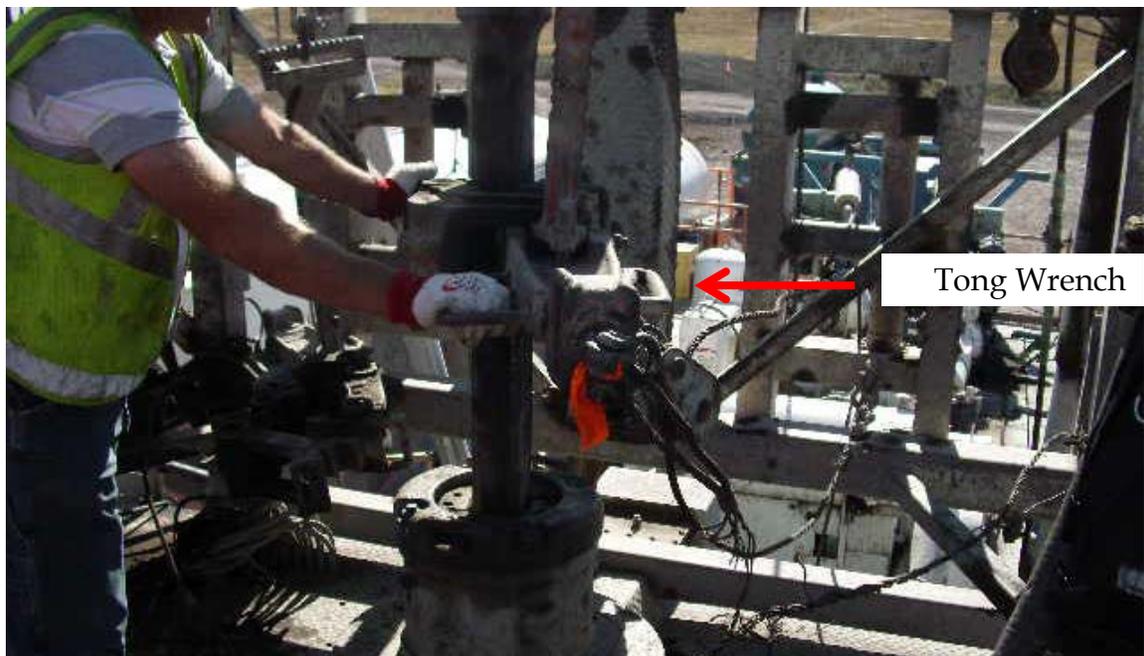
FIGURE 2: Demonstration of Tong Installation

Hunt was operating the controls that rotated the drill pipes and Brown and Houston were assigned to place the tong wrench on the "Kelly," when the maximum torque was reached. The Kelly is the square chuck that rotates the pipe during normal drilling and withdrawal of the pipe. Houston attempted to place the tong wrench on the Kelly, but the wrench failed to grip.

At the time of the fatal accident, Brown and Houston were assigned to attach the tong wrench to the Kelly after Hunt had applied as many revolutions as possible to the drill steel without initiating unscrewing of the pipe at a higher joint than desired. Both Brown and Houston were in the path of the wrench in their attempts to attach the wrench to the pipe.

Corrective Action: Weston Engineering, Inc. established an SOP, detailing the positioning of personnel prior to release of any stored energy. The SOP will ensure that all personnel involved in any aspects of drilling operations are out of the areas where they may be contacted by moving machinery or tools. The SOP was reduced to writing and all drilling personnel will receive training on this SOP prior to conducting further mine drilling operations. The training will be documented.

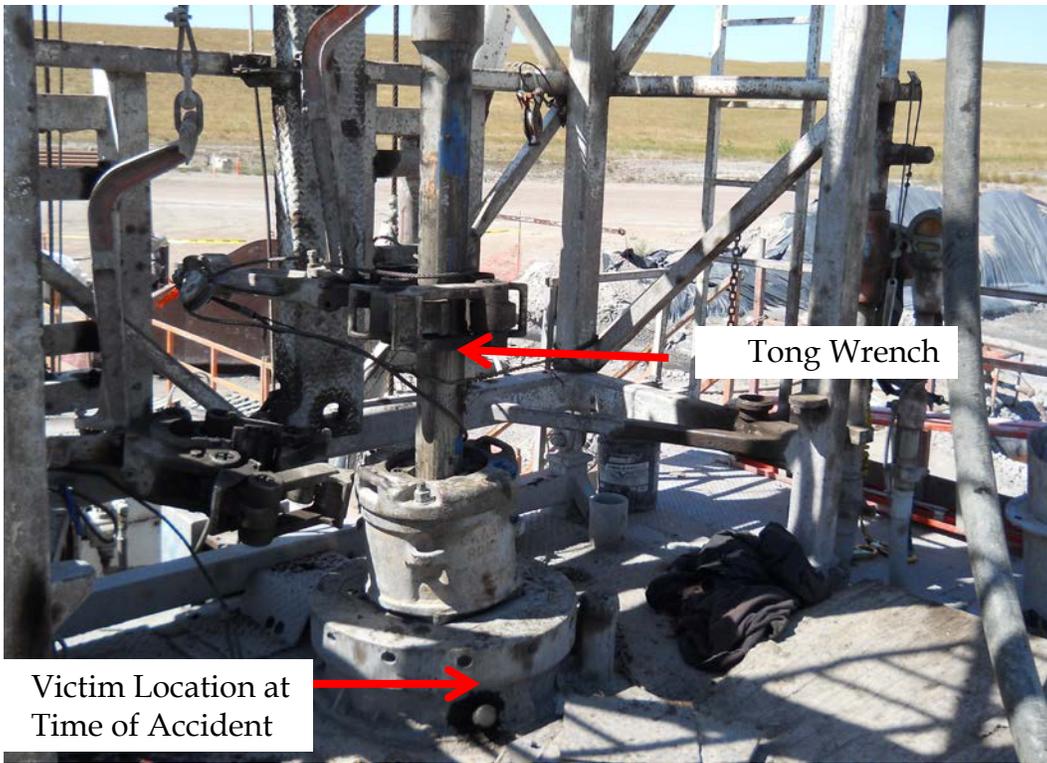
FIGURE 4: Tong Location after Accident

As Hunt began to release the reverse rotation on the drill pipes, the tong rotated. The snub line length allowed the tong to travel past the optimum 90 degree angle. When the tong passed the 90 degrees, the snub line began to fail, which caused the tong to continue through its rotational arc, striking Brown.

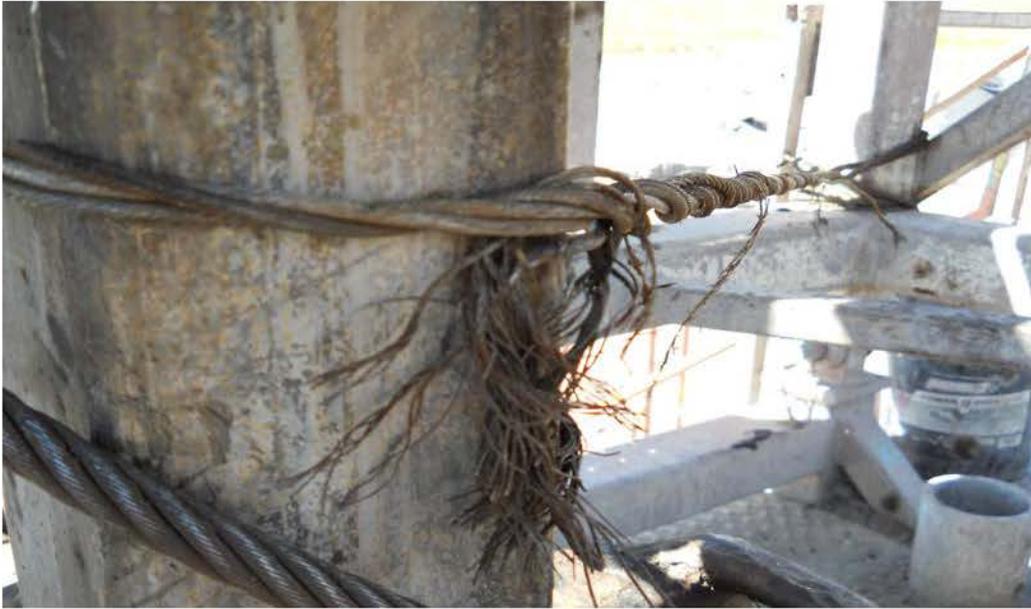
FIGURE 5: Snub Cable after Failure

Typically, the snub line wire rope is attached to the rig derrick on one end and to the end of the tong wrench on the other end. The purpose of the snub line in normal drilling is to hold the wrench in place while a new joint of drill pipe is installed down the hole. When used in the detonation application, the snub line is used to prevent the pipe from rotating because of the torque applied when the drill rotation clutch is released. The snub line in use on the day of the accident had a working length of 96 inches. This length allowed the tong to rotate past the 90 degree optimum angle putting excessive strain on the rope which led the rope passing 180 degree angle and wrapping around the drill pipe.

Root Cause: The snub line cable should not have been used in this application. There was no immediate need for persons to be on the drill deck, other than the driller. The driller is shielded by the derrick supports. The torque could have been maintained using the clutches; this would not allow anyone to be in the line of an energy release, in case of failure. The snub line used to hold torque on the drill pipes was inadequate in size and strength to hold the load that was being placed on it. The snub line in use this day was ½ inch diameter.

Corrective Action: Weston Engineering, Inc. established Standard Operating Procedures (SOP) with provisions that the drill operation will not use the snub line when attempting to hold torque on the drill pipe. In normal drilling operation and application, the snub line is adequate to hold the force. When attempting to unhook two joints of pipe, the snub line will not be used, because of inadequate size and strength. The SOP was established in writing and all drilling personnel will receive training on this SOP prior to conducting further mine drilling operations. The training will be documented.
