COAL MINE SAFETY AND HEALTH
REPORT OF INVESTIGATION

Fatal Machinery Accident
October 6, 2013

Jim Bridger Mine
Bridger Coal Company
Point of Rocks, Sweetwater County, Wyoming
Mine ID No. 48-00677

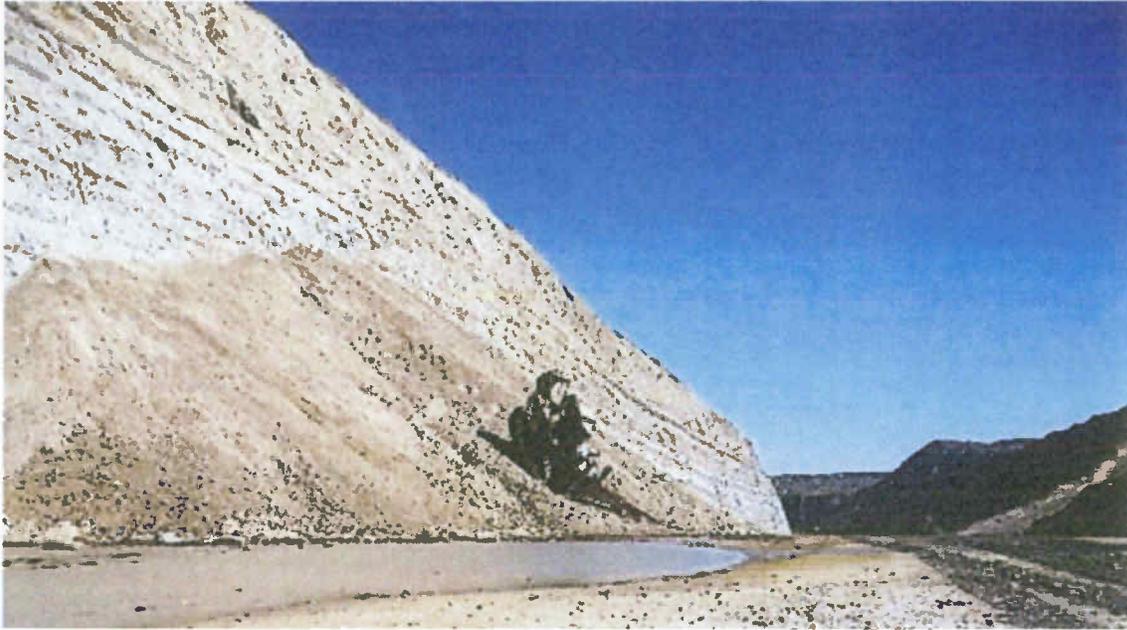
PHOTOGRAPH OF ACCIDENT SCENE

BOTTOM OF HIGHWALL
