REPORT OF INVESTIGATION

Fatal Electrical Accident
August 20, 2014

Buchanan Mine #1
CONSOL Buchanan Mining Company, LLC
Mavisdale, Buchanan County, Virginia
ID No. 44-04856

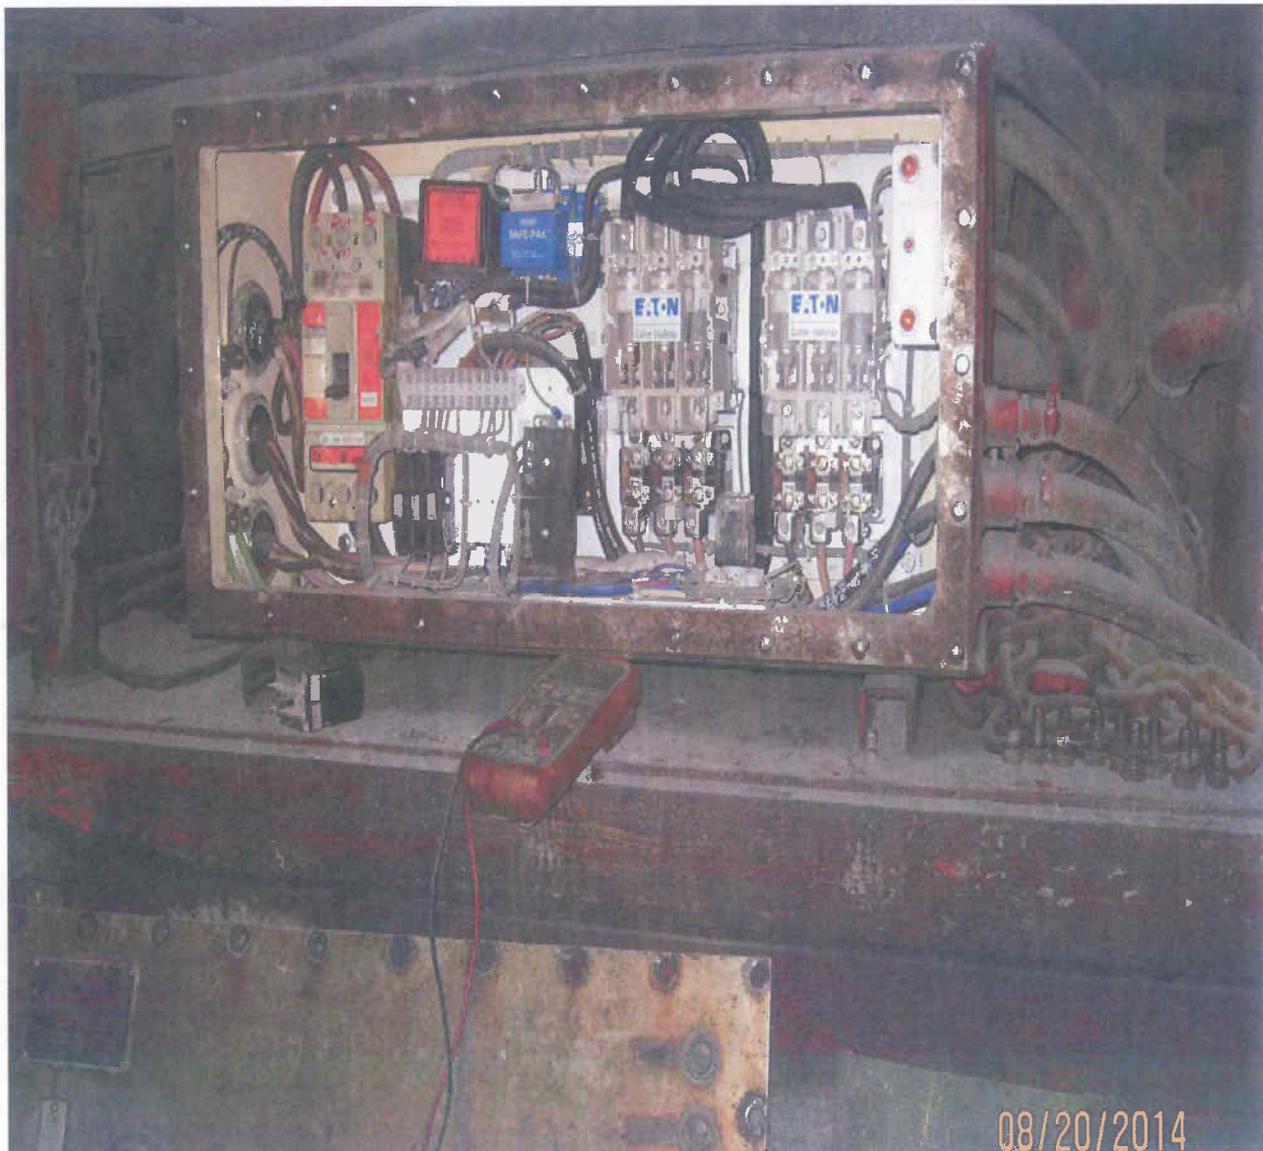
Photograph No. 1 - Explosion Proof Enclosure

At approximately 10:25 a.m. on Wednesday, August 20, 2014, Michael J. Justice (Victim), age 41, was fatally injured while working underground at the mine. The victim was working inside the explosion proof enclosure of a 600 volt alternating current (VAC) roof bolting machine. The victim came in contact with one phase lead of the 600 VAC circuit and was electrocuted.

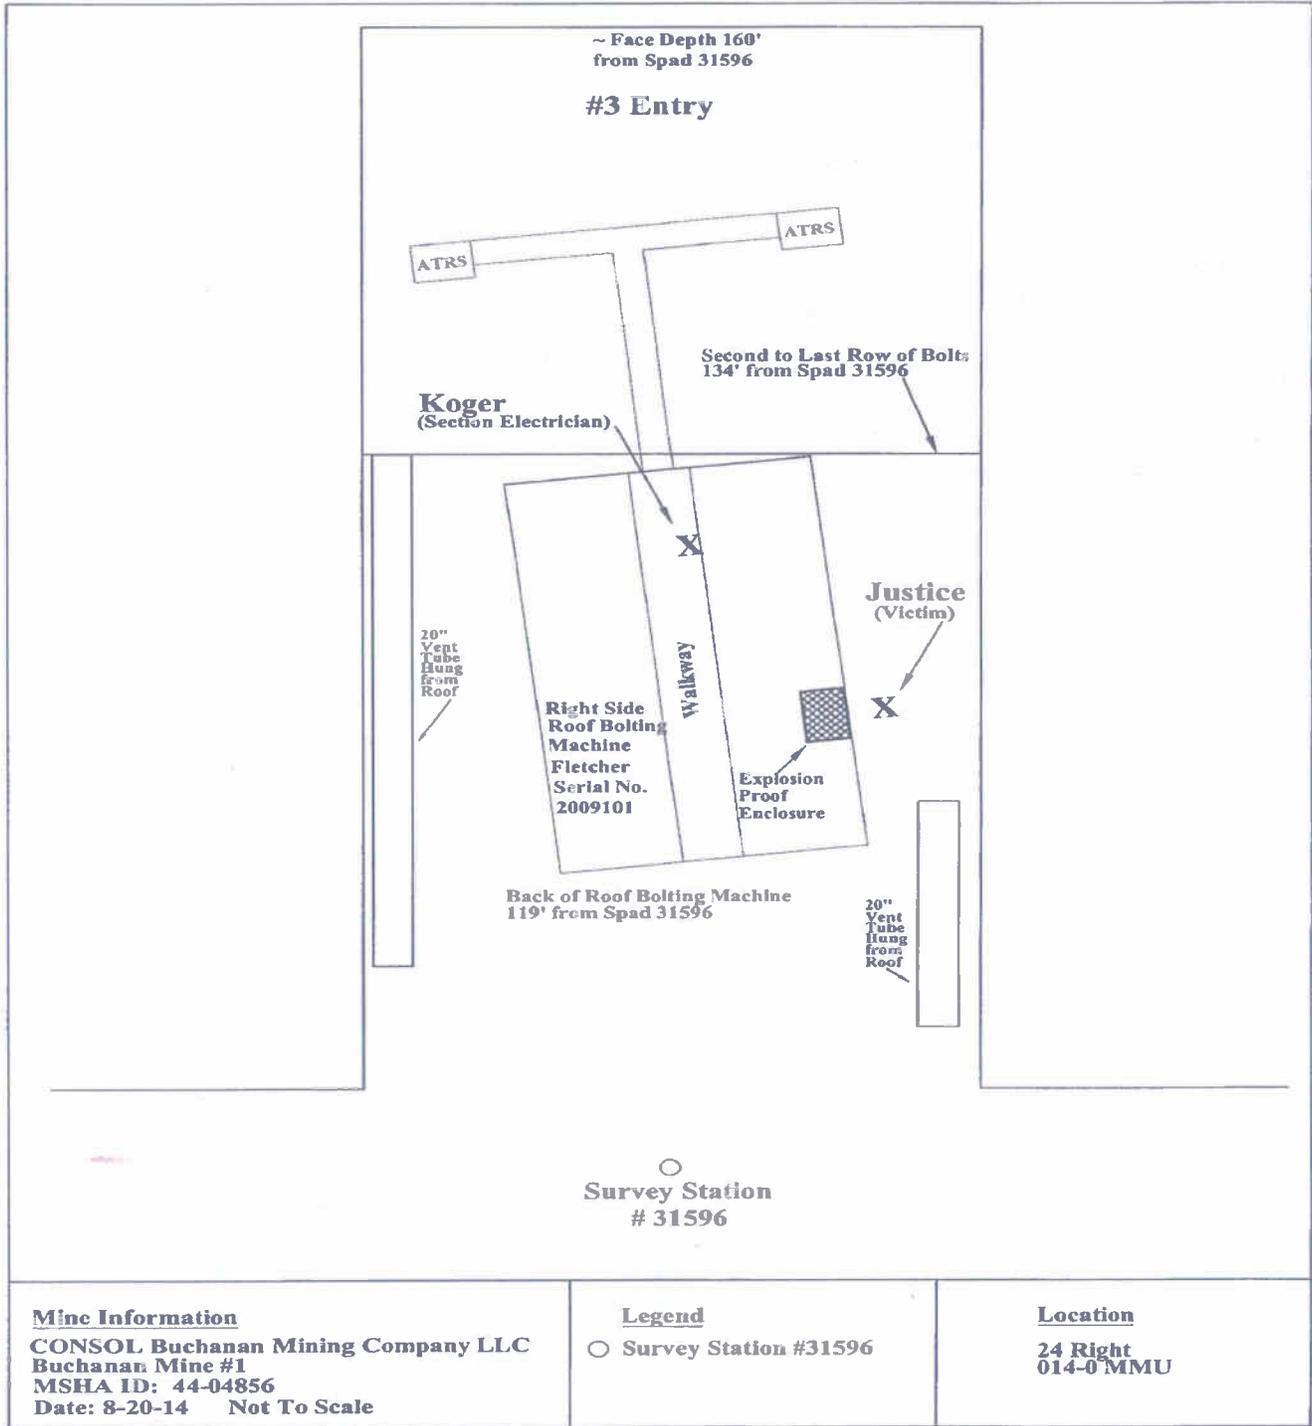
APPENDIX A - Drawing of Roof Bolting Machine in #3 Entry

The accident occurred in the No. 3 heading approximately 127 feet inby survey station No. 31596 on the 24 Right section off 3 East Mains, 014-0 MMU. The section consisted of 4 entries. Entries No. 2 and 3 provide intake air to ventilate the section. Entries No. 1 and No. 4 are used for air returning from the section.

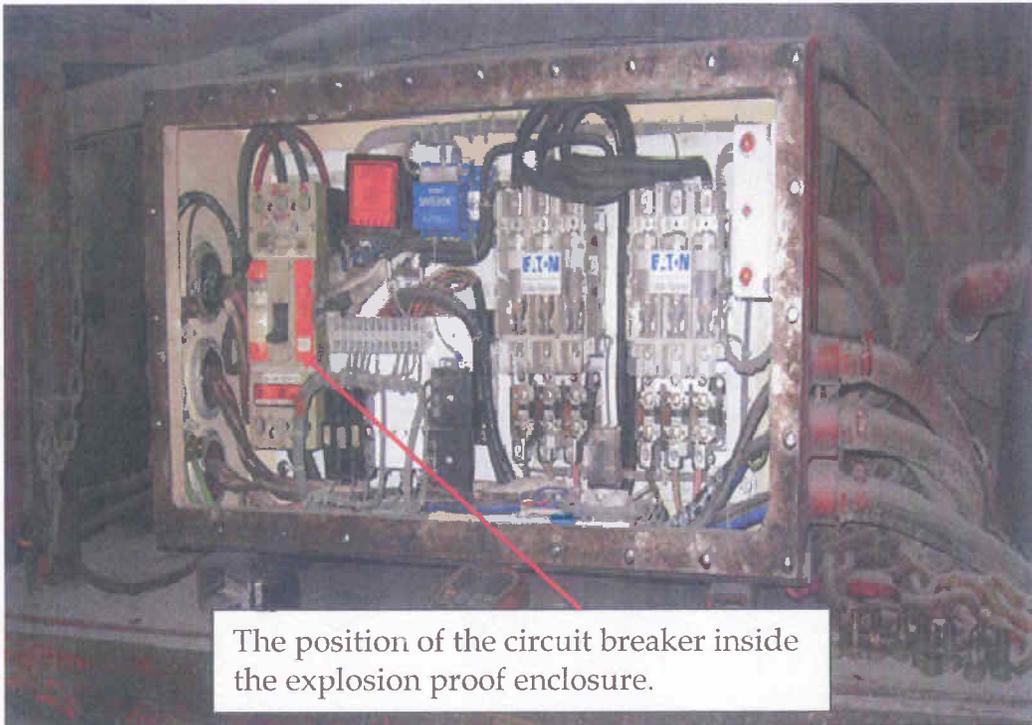
APPENDIX C - Photographs of Circuit Breaker

During the investigation, it was determined that the roof bolting machine's onboard circuit breaker had wiring deficiencies. The connection of the red phase lead (closest to the IS relay) to the line side of the circuit breaker had several strands of copper wire protruding out of the connection lug and one strand of the wire protruding toward the IS control relay on which the victim was working. The IS relay was located

The position of the circuit breaker inside the explosion proof enclosure.

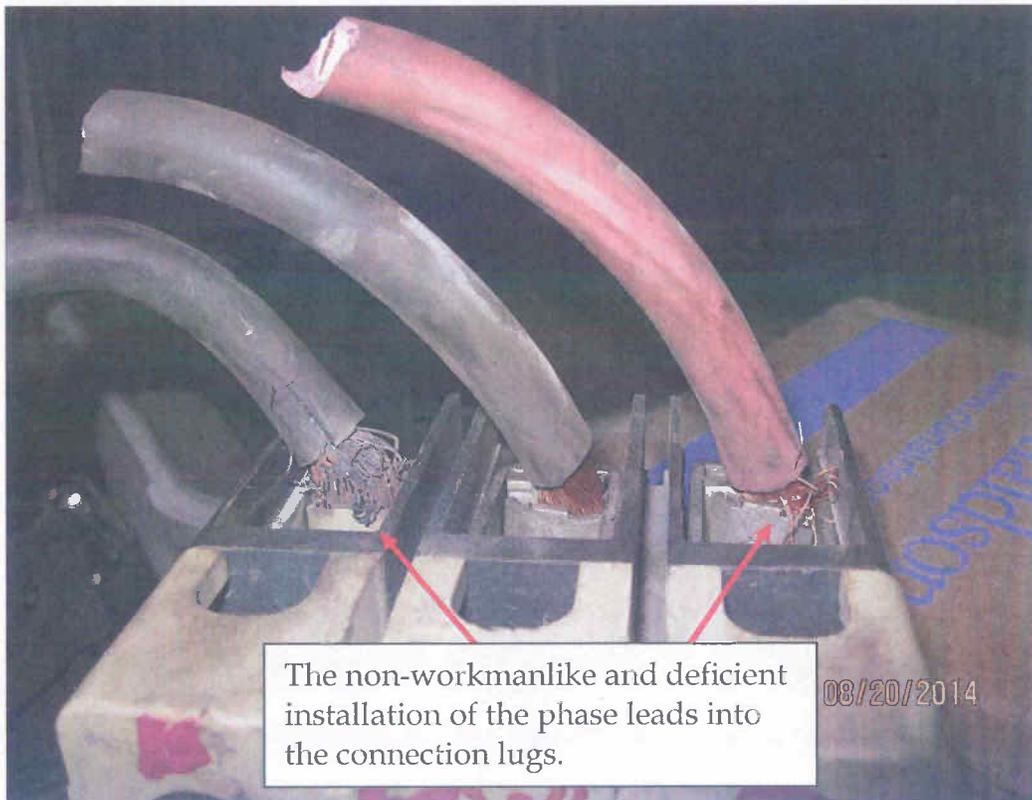
approximately 1½ inches from the copper strand. Also, the white phase lead (farthest from the IS relay) was not properly installed in the connection lug. There were strands of wire protruding around the connection lug and the lead was loose in the lug which caused heating and damage to the insulation (See photographs in the Appendices).

When the new circuit breaker was installed, approximately 7 to 10 inches of the white phase lead had to be removed in order to access the portion of the lead that was not damaged by heating. The protruding wire strands of the red phase lead were one possible contact point. The autopsy indicated two thermal injuries to the tip of the ring finger of Justice's left hand - a 2 centimeter blister and one 0.9 centimeter blister.

Examination of the onboard circuit breaker was conducted on September 16 and September 17, 2014, at the MSHA Approval and Certification Center (A&CC) in Triadelphia, West Virginia. The examination of the circuit breaker did verify eight deficiencies; however, none of the deficiencies found indicated that the circuit breaker contributed to the accident. The examination verified that there were several conductor strands of #26 AWG that were not captured in the terminal lug closest to the IS control relay on which the victim was working.

The non-workmanlike and deficient installation of the phase leads into the connection lugs.
