REPORT OF INVESTIGATION

Surface Coal Mine

Fatal Fall of Highwall  
October 7, 2014

Tinsley Branch HWM 61  
Commonwealth Mining, LLC.  
Pineville, Bell County, Kentucky  
ID No. 33-04642

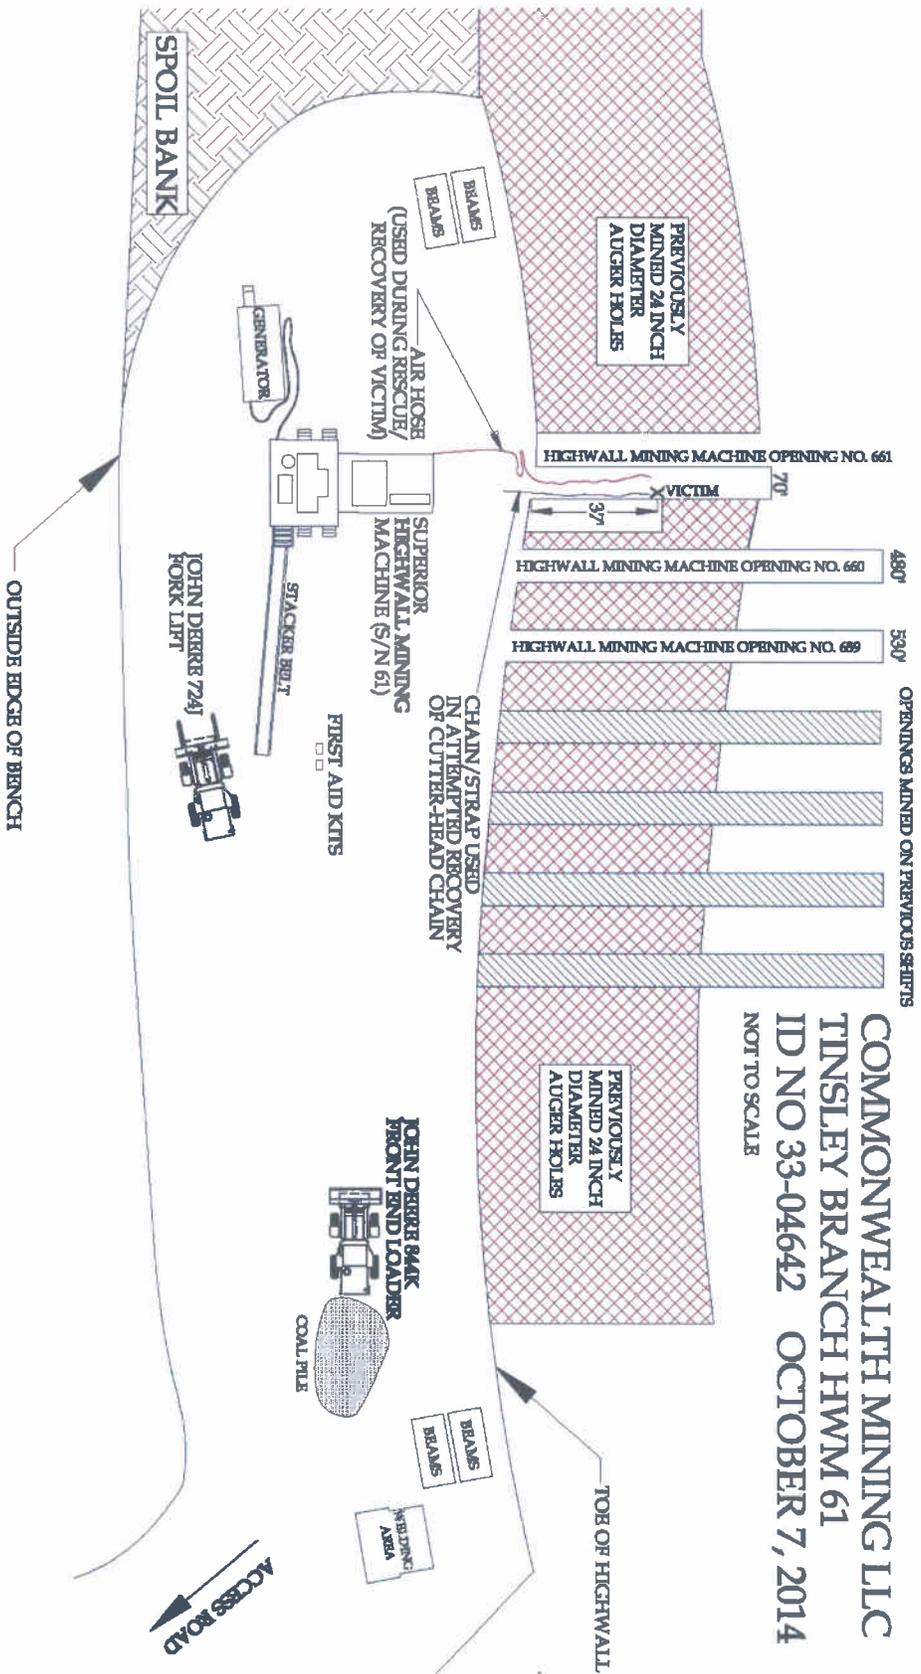
# SKETCH OF ACCIDENT SCENE

On Sunday, October 6, 2014, the night shift crew was mining in the 400 feet deep, #659 opening (see sketch of Accident Scene). Their normal production shift ended on October 7, 2014 at 6:00 a.m. The day shift began at 6:00 a.m., with Anthony Cornett, Day Shift Foreman, performing a pre-shift examination of the highwall mining machine pit area. No hazardous conditions were recorded for this examination. Justin Mize, Forklift Operator, began his shift at 6:00 a.m. and proceeded with his normal routine.

From the facts gathered during the investigation, the highwall mining machine opening where the accident occurred had only been driven 70 feet due to the cutter-head chain breaking. The cutter-head chain was located 37 feet from the surface into the opening. Twelve to twenty inches of loose drawrock and cap coal was observed hanging from the roof of the highwall mining machine opening where the accident occurred. Additionally, drawrock was present in the roof of the #659 highwall mining machine opening which was mined earlier in the shift. Drawrock that had already fallen from the roof was also observed on the floor of the #659 highwall mining machine opening.

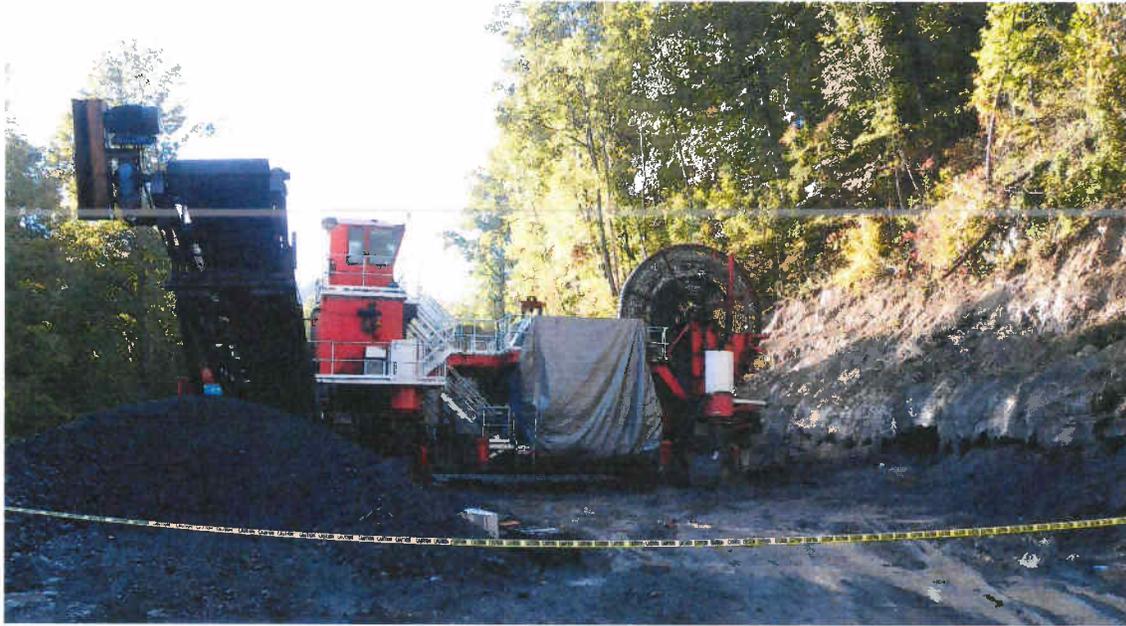
PHOTOGRAPH OF THE ACCIDENT SCENE

At approximately 5:00 p.m. on Tuesday, October 7, 2014, Justin Mize was killed at Commonwealth Mining, LLC's Tinsley Branch HWM 61 mine. The victim crawled 37 feet into an unsupported opening that was mined with a highwall mining machine to retrieve a broken cutter-head chain when a rock that measured approximately 6 feet long, 8 feet wide, and 16 inches thick fell on him, causing fatal crushing injuries.

*Corrective Action:* Mine Management revised the approved training plan by adding categories to assure that miners are specifically trained that no person shall be permitted to enter a highwall miner opening, except with prescribed conditions as approved by the District Manager. Categories revised include: New Miner Training, Experienced Miner Training, Annual Refresher Training, Task Training, and Hazard Training.

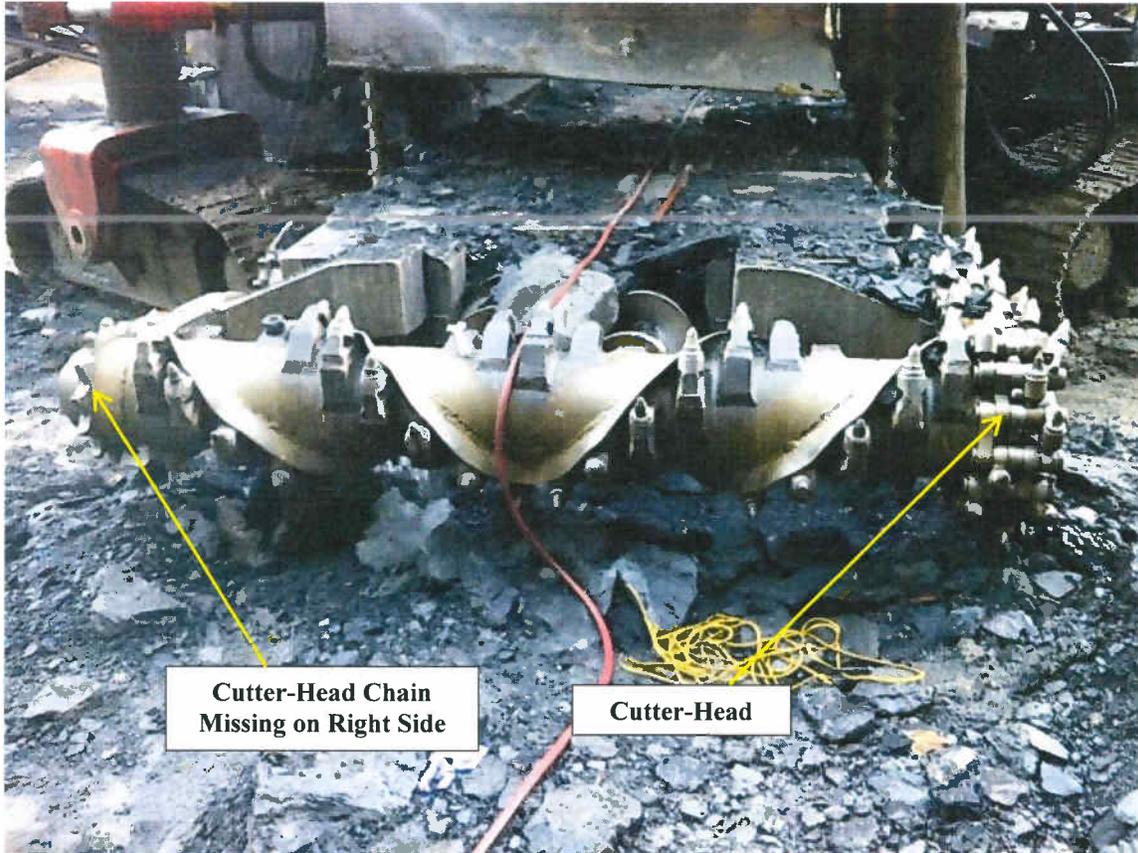
**Cutter-Head Chain Missing on Right Side**

**Cutter-Head**

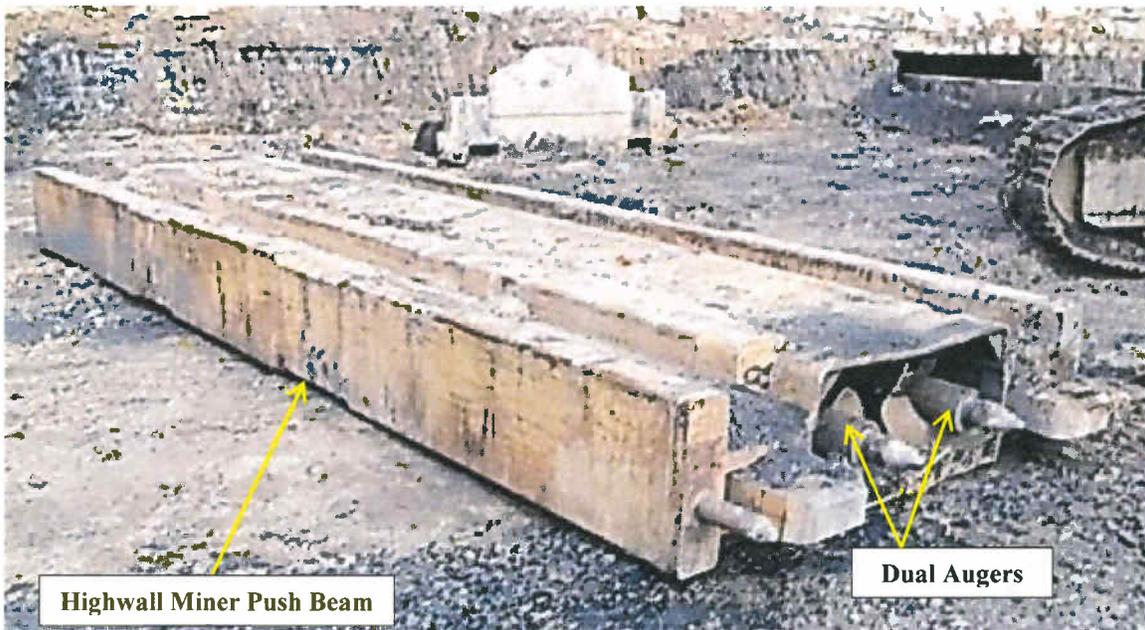
**Highwall Miner Push Beam**

**Dual Augers**
