REPORT OF INVESTIGATION

Fatal Machinery Accident
January 28, 2015

Brubaker Mine
LCT Energy, LP
Hooversville, Somerset County, Pennsylvania
ID 36-09939

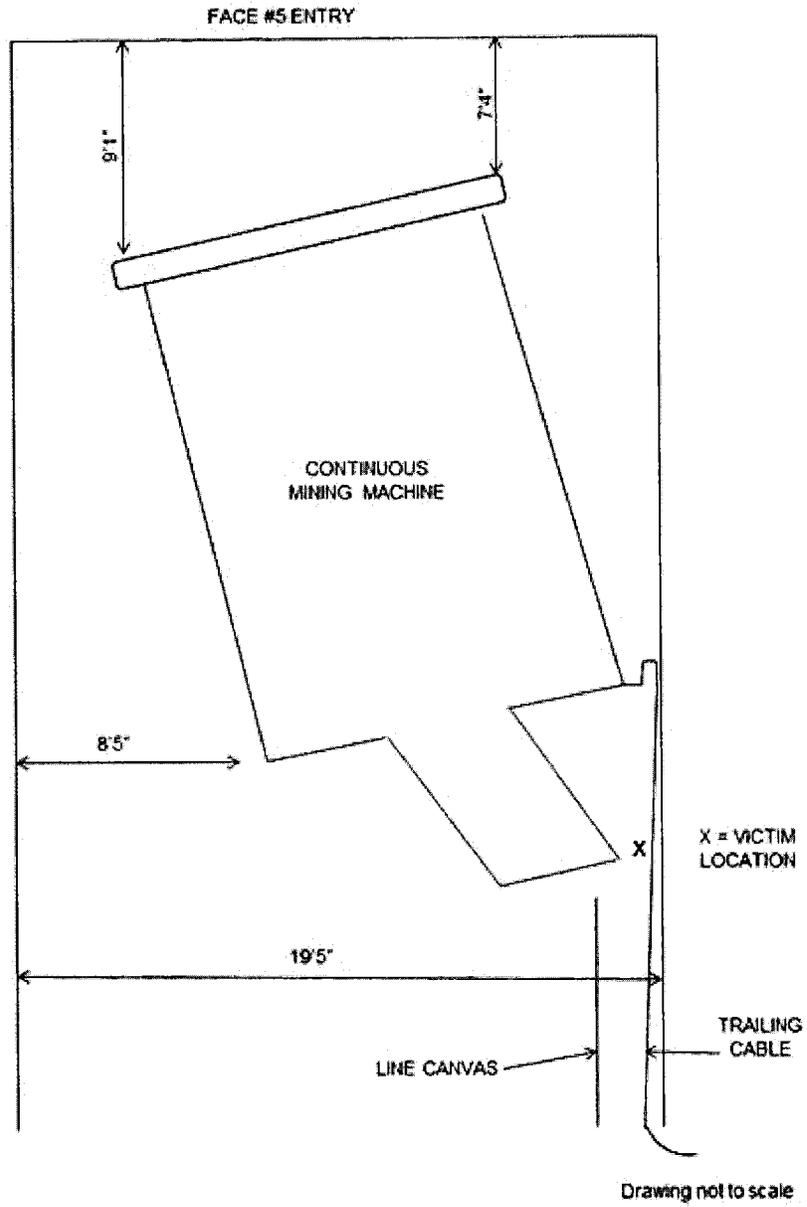
ACCIDENT SITE

The accident occurred in the face area in the No. 5 entry approximately 80 feet in by survey spad No. 2035 in the Lebeau Mains section (MMU 001-0). This entry was mined 82 feet in by the last open crosscut. The entry was approximately 19 feet and 5 inches in width and 50 inches in height. The roof had permanent roof support installed to the face and no hazardous conditions were observed in the roof and ribs in the area. The mine roof, ribs, and mine floor were relatively dry.

When the investigators arrived to begin the operation and function tests on the continuous mining machine, it was in the same position that it was in at the time of the accident, except that the conveyor boom was in the position that Matsko placed it when he moved it to free Kline. The front right corner of the mining machine was 88 inches out by the face and 35 inches from the right rib facing in by. The cable anchor point located on the right rear of the mining machine when measured was 7 inches from the right rib. There was a 5 to 6 foot loop of slack trailing cable and water line along the right rear corner of the mining machine. The gathering head (pan) of the mining machine was found in the raised position. The imprints of the mining machine tracks found on the mine floor extended 5 to 6 feet in front of where the front edge of the tracks were located. From all indications, the continuous mining machine was being backed away from the face at the time of the accident.

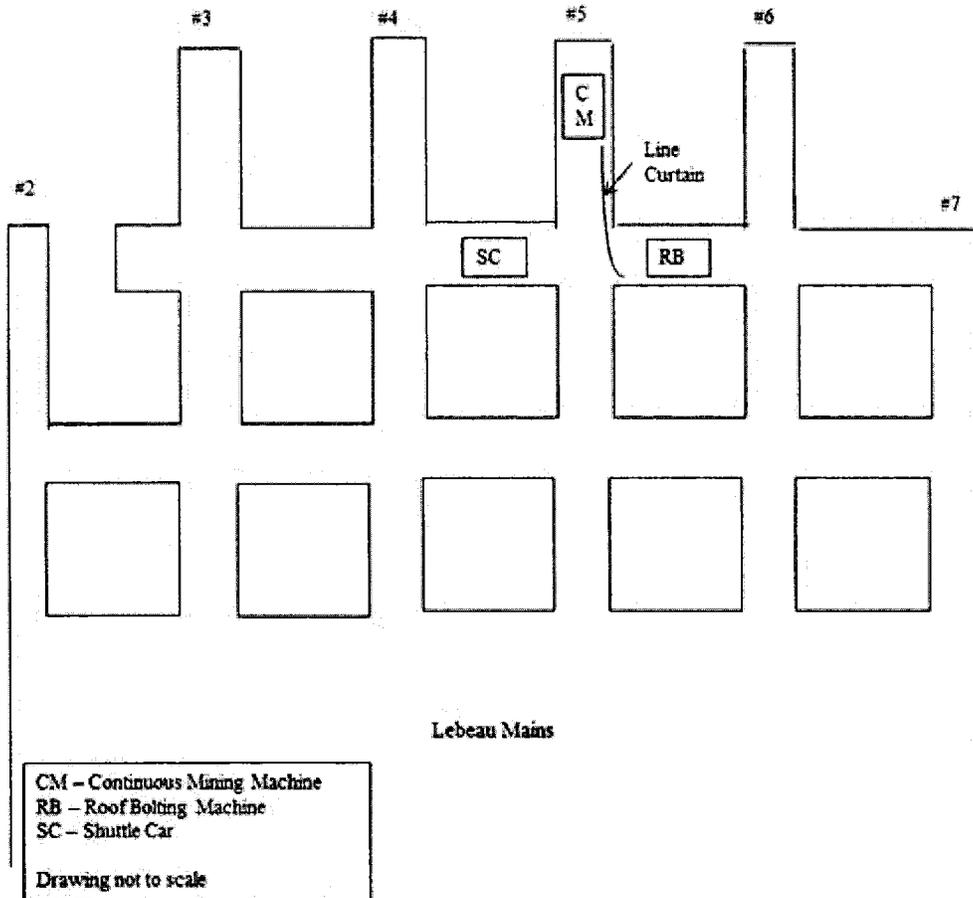
Expanded View of the Accident Scene

Kline operated the continuous mining machine and mined the No. 3 entry, mined a crosscut from No. 3 entry to No. 2 entry, and mined the No. 2 and No. 7 entries. After the No. 7 entry was mined, Kline moved the mining machine to the No.6 entry to load the rock that fell in the face area. Houston and Marcum finished bolting the No. 5 entry and then backed the roof bolting machine into the last open crosscut from the No. 5 entry to No. 6 entry, and waited for Kline to back the mining machine out of the No. 6 entry (see Appendix A).

Kline finished loading the rock and then began moving the mining machine from the No. 6 entry to the No. 5 entry. He trammed the mining machine in reverse outby the last open crosscut in the No. 6 entry, continuing through the next to last open crosscut, and then just outby this crosscut in the No. 5 entry. From that point he trammed the mining machine forward towards the face of the No. 5 entry.

While pausing, Matsko heard the scrubber fan running and saw the mining machine's trailing cable and water line moving inby. When he observed the trailing cable and waterline stopped moving, Matsko went to the mining machine and saw Kline pinned between the conveyor boom of the mining machine and the coal rib. Kline was facing inby (towards the No. 5 face) with the conveyor boom against the left side of his chest and his right side was against the coal rib. The mining machine and scrubber fan were running and the nylon sling (rope) around the trailing cable and water line was attached to the conveyor boom.
