REPORT OF INVESTIGATION

Fatal Roof Fall Accident
February 20, 2015

Heilwood Mine
Rosebud Mining Company, Inc.
Heilwood, Indiana County, Pennsylvania
I.D. Number 36-09407

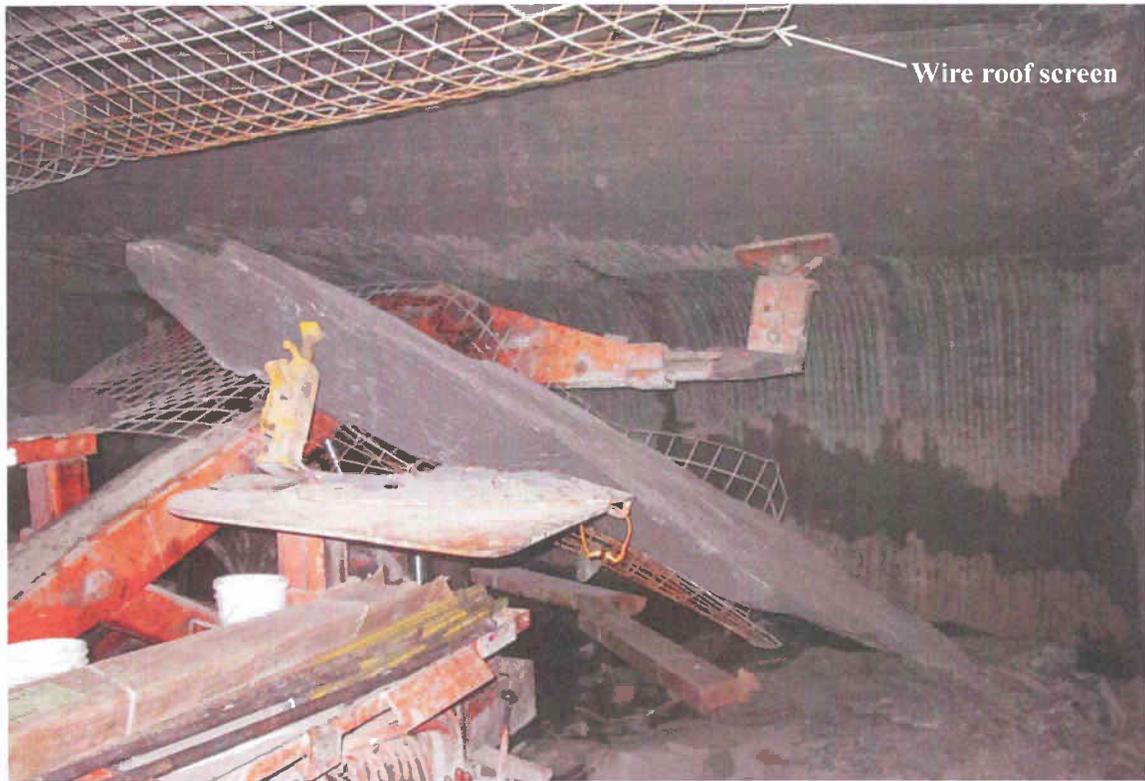
**NUMBER 2 SLOPE ENTRY, APPROXIMATELY 170 FEET INBY SURVEY STATION
NUMBER 4794 IN THE A MAINS SECTION**

The accident occurred in the number 2 slope entry, approximately 170 feet inby survey station number 4794 in the A Mains section, MMU 001-0. The mining height at the accident scene averaged 8.3 feet and the width of the number 2 entry was 19 feet. The immediate mine floor consisted of gray shale, with pockets of shale bedding that were broken out forming undulations in the mine floor. The mine ribs were in good condition, showing no signs of sloughage and consisted of shale partings throughout the mining height.

The rock that struck Trimble was found leaning against the main support of the ATRS, on the right side drill canopy and the other end on the mine floor with the inby edge approximately 5 inches outby the back edge of the ATRS. The placement of the rock suggests that the rock did not contact the ATRS. The rock measured 0.25 to 1.3 feet in thickness, 3 feet in width, and 11.5 feet in length. The rock weighed approximately 4,400 pounds. The rock was shaped similar to a parallelogram.

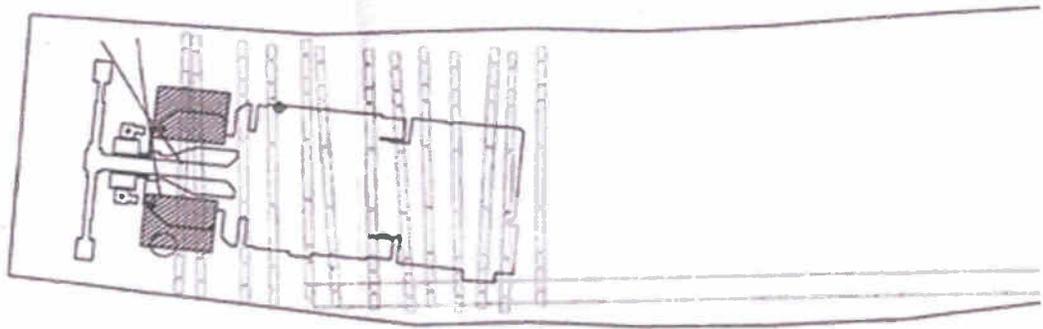
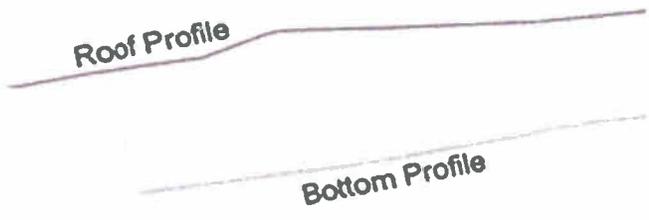
Appendix B
Roof Bolting Machine at Face of Number 2 Entry

In the number 2 entry, A. Mumau and Trimble installed one row of roof bolts as the primary roof supports and one row of cable bolts as supplemental roof supports. There was approximately 10 feet between the last full row of bolts and the face in the number 2 entry. A. Mumau trammed the roof bolting machine inby and positioned the ATRS with the inby edge of the ATRS pads 5 feet inby the last full row of roof supports.

At approximately 2:05 p.m., Trimble was positioned between the roof bolting machine drill mast and the ATRS. Witnesses stated that Trimble was attaching support wire to the previously installed wire roof screen and the piece of wire roof screen that would be installed. A large piece of roof rock that measured 0.25 to 1.3 feet in thickness, 3 feet in width, and 11.5 feet in length, fell from the roof. The rock fell in such a manner that the ATRS could not prevent the rock from hitting Trimble. The edge of the rock closest to Trimble struck and pinned him in an upright position against the roof bolting machine drill canopy.

The roof bolting machine had not been moved when accident investigators arrived at the scene. A pump jack was installed between the top of the drill canopy and the rock to free the victim. The piece of wire roof screen that the victim and A. Mumau were preparing to install measured 5 feet wide by 14 feet in length.

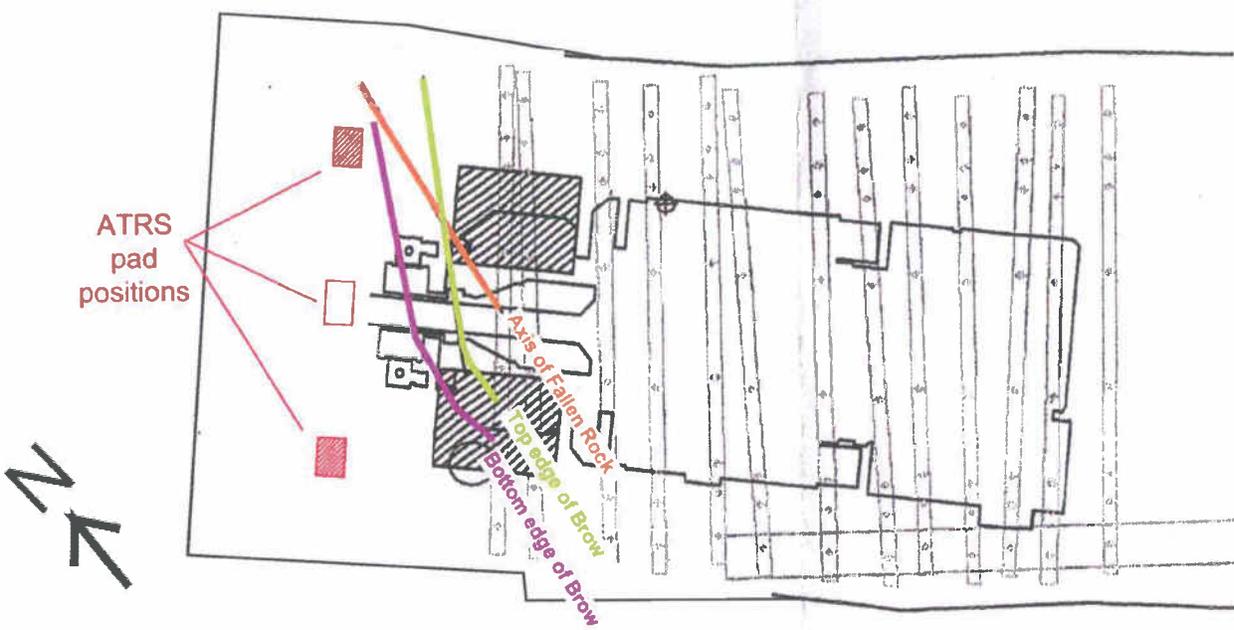
Appendix D
Geological Features

Overburden at the accident site was approximately 690 feet. No undermining or over mining with older workings exists in the vicinity of the slope. The number 2 entry had been developed to the top of the Brookville Seam but had not yet reached the coal. Weak bedding contacts are where layers of roof strata may separate from each other. A 15 percent downward entry slope formed ledges in the roof as a result of the relatively horizontal bedding. Because of the weak

bedding contacts, as the mining cut is advanced down slope, roof stratum can peel away from other roof stratum until the roof strata is sufficiently thick enough to remain intact and not peel away.

In this manner, ledges or brows are formed in the roof. The accident site where roof bolting was being conducted was in such a transition zone as the bolting was advancing towards a ledge in the mining cut. The mine roof where roof bolts had been installed, the mine roof was the bottom of an overlying gray shale bed. A general lack of continuous mining machine cutting bit marks in this roof for the last 8-foot distance of roof support installation indicated that the underlying gray shale bed easily peeled away from the overlying shale bed at the contact.

Inby the last installed roof support, a brow ran diagonally across the entry towards the inby right hand corner of the cut at roughly a 10° angle to the last installed roof support. After the accident, the bottom exposed portion of the brow where the roof remained intact and where it was initially cut began roughly 4.5 feet from the left side rib. The top exposed portion of the brow where it was in contact with the overlying shale bed began roughly 6 feet from the left pillar rib (see Appendix D). The exposed surface of the brow, in the right side half of the entry, dipped inby towards the end of the cut at roughly 55° from horizontal, forming a roughly 2.5-foot wide exposed face that was created by the fallen rock.
