MAI-2014-14

REPORT OF INVESTIGATION

**Fatal Ignition/Explosion of Gas
June 18, 2014**

**Hanson Aggregates Southeast, LLC
Brewer Sand
Jefferson, Chesterfield County, South Carolina
Mine I.D. No 38-00122**

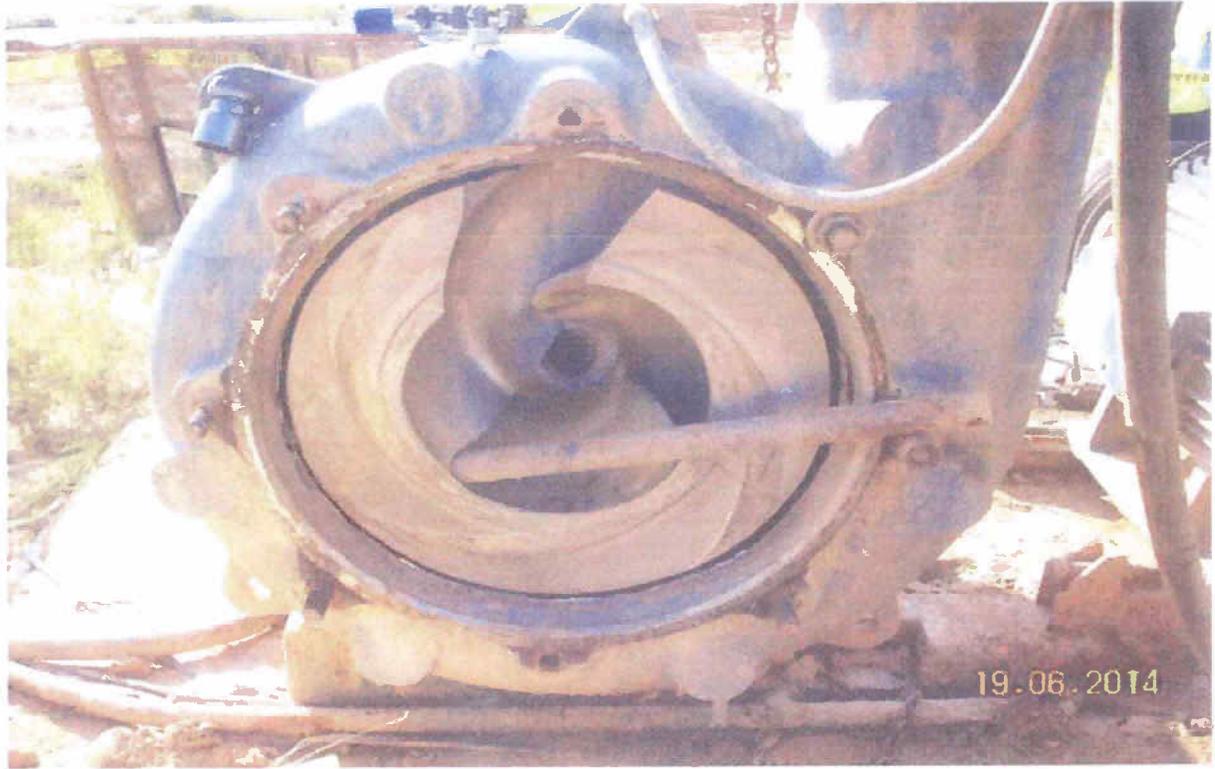
Christopher Melton, Production Supervisor, age 41, was killed on June 18, 2014, while he and two contract mechanics were attempting to replace an impeller on a waste water slurry pump. After several failed attempts by the mechanics to loosen the impeller by prying and hammering, one of them used a torch to apply heat to the sealed impeller hub in the center area of the impeller, but the impeller did not loosen. Melton then took the torch and applied heat to try to loosen the impeller hub. The center of the impeller suddenly exploded and metal fragments struck him.

Since the attempts to loosen the impeller hub by prying and hammering were unsuccessful, Arant went to the welding truck and got an oxygen/acetylene torch to apply heat to the impeller. Arant stood in front of the impeller and applied heat to the impeller hub for approximately three minutes. Melton came to help with the task and told Arant that he would take over on the torch to apply heat to the impeller for a few more minutes. As Arant was walking behind the pump to turn the shaft, the hub of the impeller exploded and metal struck Melton, causing him to fall to the ground. The accident occurred at approximately 12:35 p.m.

The impeller is made of hardened, cast metal alloy and threaded onto the end of the pump drive shaft. The central part of the inner impeller plate, referred to as the hub, is cone shaped and when installed, completely covers the end of the shaft. When the impeller is threaded into position on the shaft, the cone creates a sealed

cavity between the back side of the cone section and the end of the shaft. The impeller and the shaft are manufactured with right-hand threads. The pump manufacturer's service literature recommends the application of a heavy amount of anti-seize compound on the shaft threads prior to installing an impeller onto the shaft.

The service literature also provides a warning against the application of heat to the impeller because there is an explosion hazard. Additionally, two warning labels are located on the front legs of the pump on opposite sides. The warning labels state "Do not apply heat to the impeller hub or nose due to the sealed cavity at the impeller nose - Danger of Explosion."

Root Cause: Management failed to ensure that work procedures were established for persons to safely perform maintenance work on waste water slurry pumps. The manufacturer of the pump warned that heat was not to be applied to the impeller hub; however no procedures were established to prevent persons from applying heat to the impeller hub. Persons were not task trained on maintenance work for waste water slurry pumps.

Corrective Action: Management established Standard Operating Procedures (SOP) for persons to safely perform maintenance work on waste water slurry pumps. All miners were trained regarding the SOP's to be used when performing maintenance on a slurry pump.
