MAI-2014-15

REPORT OF INVESTIGATION

**Fatal Electrical Accident
July 21, 2014**

**Murray Mines Inc.
Murray Mines Inc.
Ridgeville, Colleton County, South Carolina
Mine ID No. 38-00136**

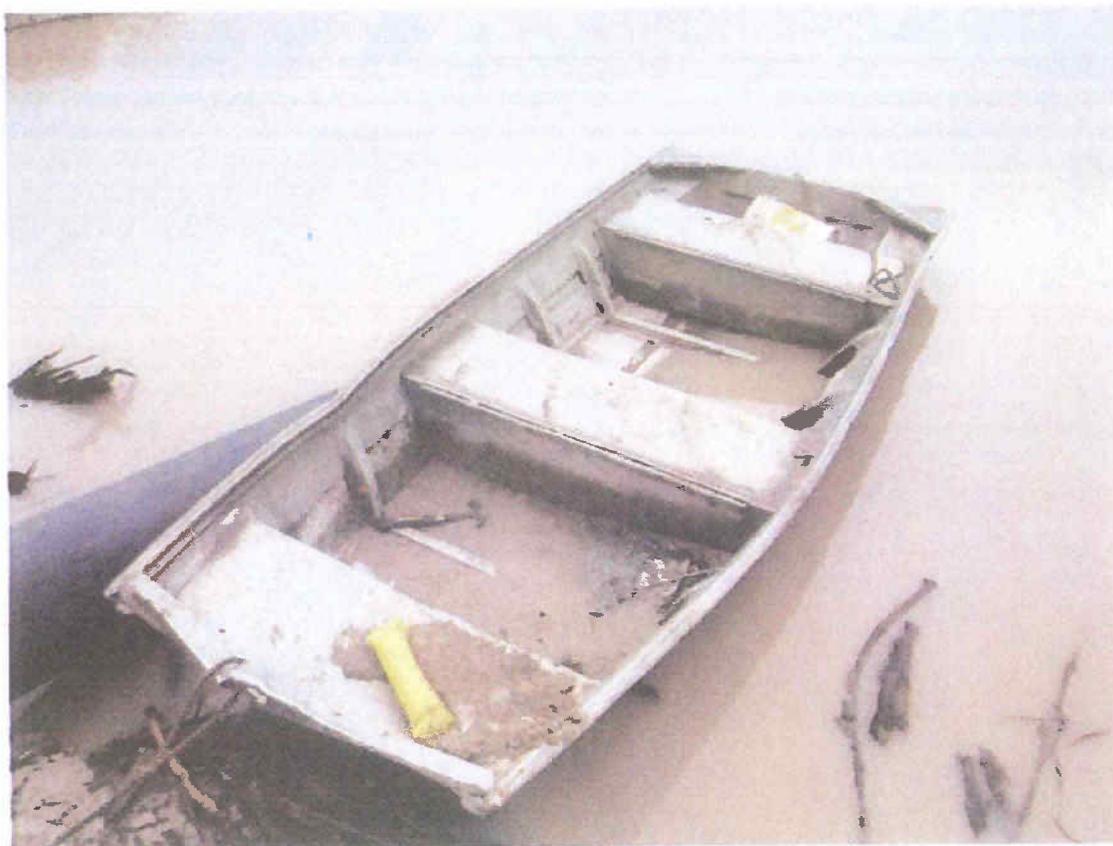
The flat bottom, aluminum boat involved in the accident was 12 feet long and 46.5 inch wide. This boat was the only access boat to the dredge that was provided at the mine.

Aluminum paddle boat

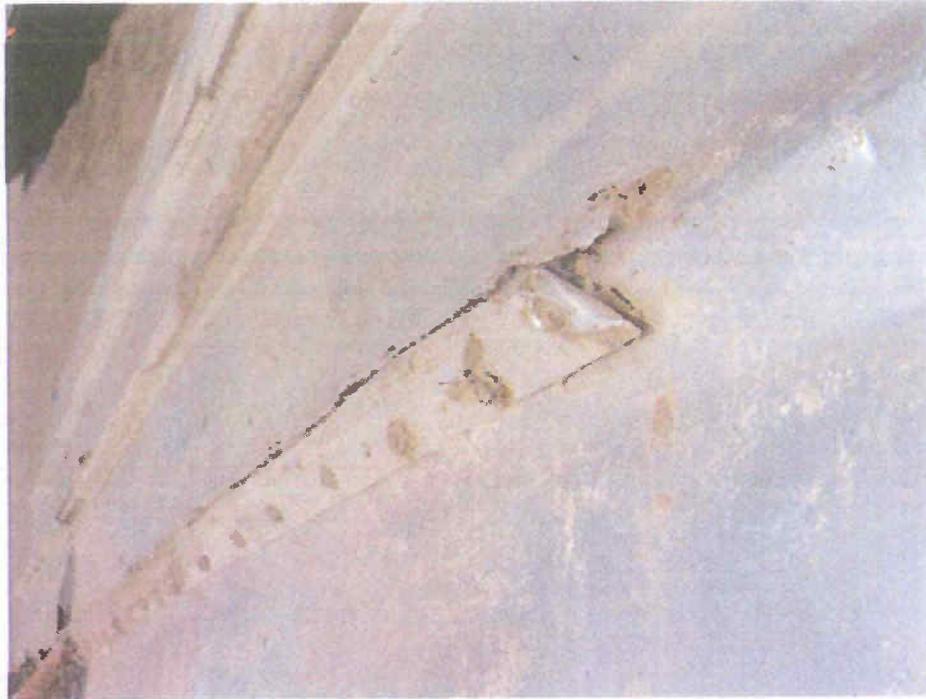
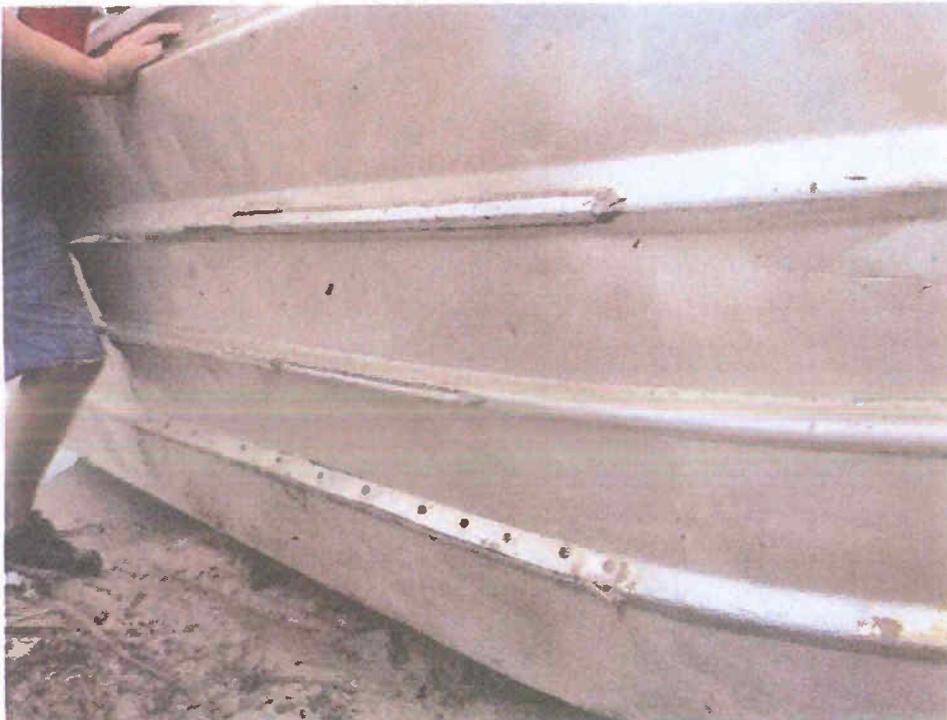
During the inspection of the boat, investigators noted three ribs located on the bottom of the boat that had been repaired. The right (starboard) side rib was observed with two strips of metal, one on each side of the rib, that had been placed over a strip of rubber and secured by screws into the bottom of the boat. A section of the metal strips, toward the rear of the boat, was observed separated with a thin piece of rubber lodged between the metal strip and the boat bottom.

Sharp edges under the aluminum paddle boat

Corrective Action: Management discontinued using the dredge as a mining method. An open pit excavation system will now be used to mine the material. The dredge and the associated electrical conductors have been removed from service.

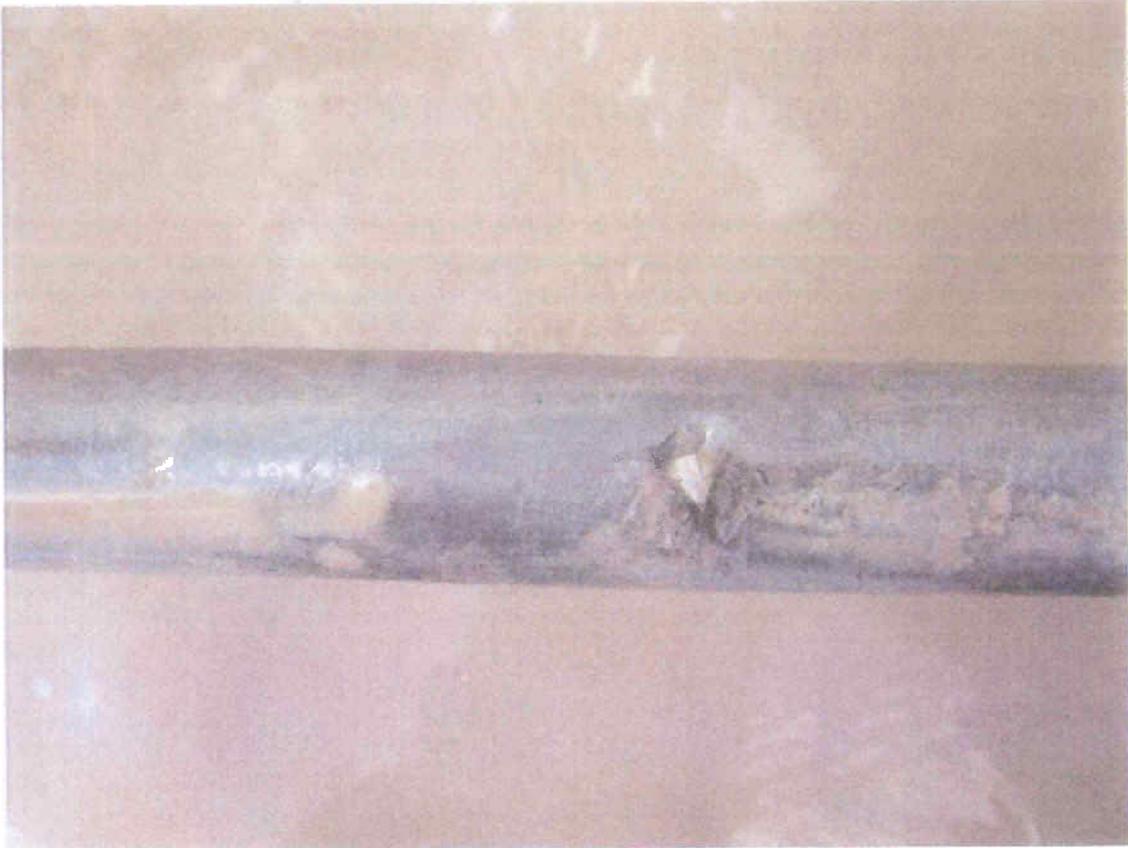
Martin paddled the boat approximately 300 feet from a dredge operating in a pond to reach the power conductors to move them away from the shoreline. The conductors had been installed from the motor control center along the bank of the pond, in the pond, and then to the dredge. Martin was electrocuted when he got out of the boat and attempted to pull it across the conductors. Sharp edges along the bottom of the aluminum boat penetrated the conductor's insulation.

Root Cause: Management failed to ensure that the individual power conductors supplying power to the dredge were provided with an outer jacket to protect them from mechanical damage thereby exposing miners to an electrical hazard.

Cut on conductor
