REPORT OF INVESTIGATION

Surface Nonmetal Mine
(Crushed and Broken Limestone)

Fatal Fall of Person Accident
August 25, 2014

Gardenscape of New York
Gardenscape of New York
Gouverneur, St. Lawrence County, New York
Mine I.D. No. 30-00007

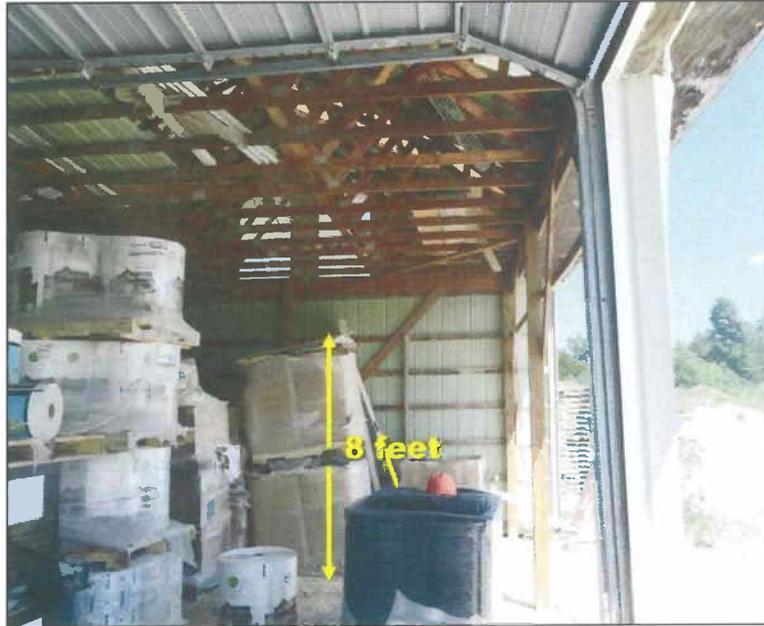
The accident occurred in the bag storage building on the east end of the mine. The structure is a three-sided enclosure built to store and shelter stacked pallets of new bags and other materials needed for the mine (see Figure 1). The earthen floor is covered with fine gravel and free of debris. Wire mesh bag support columns for the onsite dust collectors and wooden planks are stored in the building's rafters approximately 12 feet from ground level.

Figure 1 - Bag Storage Building showing stacked pallets where victim had been kneeling (prior to the accident).

Corrective Action: All materials were removed from the overhead rafters and stored in a safe manner. In addition, management established written policies and safe work procedures, including the use of ladders for any work being performed overhead. Miners were trained in the new policies and procedures.

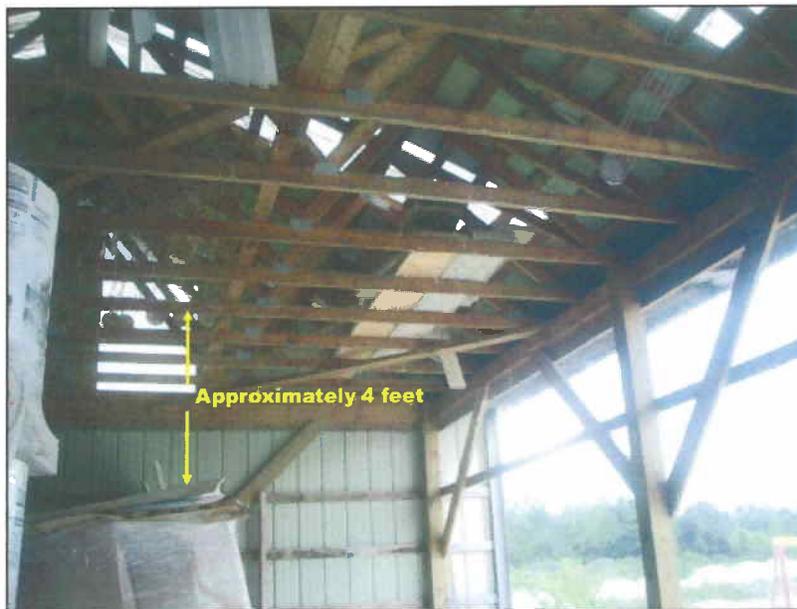
The evidence gathered during the investigation indicated that the victim had climbed approximately 8 feet on top of two stacked pallets and reached for wooden planks in the rafters above him (see Figures 2 and 3). Each wooden plank was approximately 2-inches thick by 12-inches wide by 12-feet long and weighed 30 pounds. The victim had taken down two wooden planks before falling to the ground.

Figure 2 - Distance from top of stacked pallets to rafters.

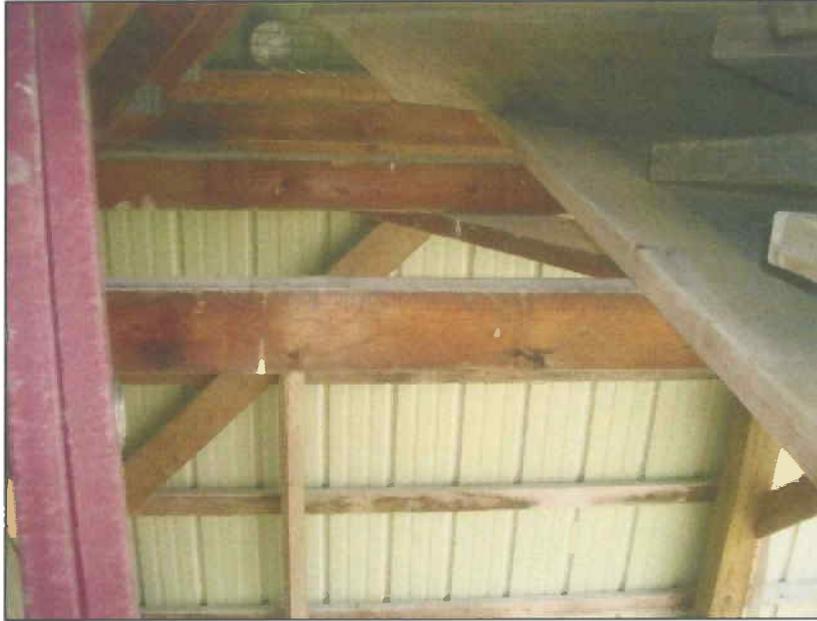
**Figure 3 - View of rafters where wooden planks were stored.
(Note: limited dust where planks had been removed by the victim)**
