REPORT OF INVESTIGATION

Surface Nonmetal Facility
(Cement)

Fatal Fall of Person Accident
October 10, 2014

F. T. Silfies
Contractor ID No. E714
at
Lehigh Cement Company LLC
Evansville Plant
Fleetwood, Berks County, Pennsylvania
Mine ID No. 36-00185

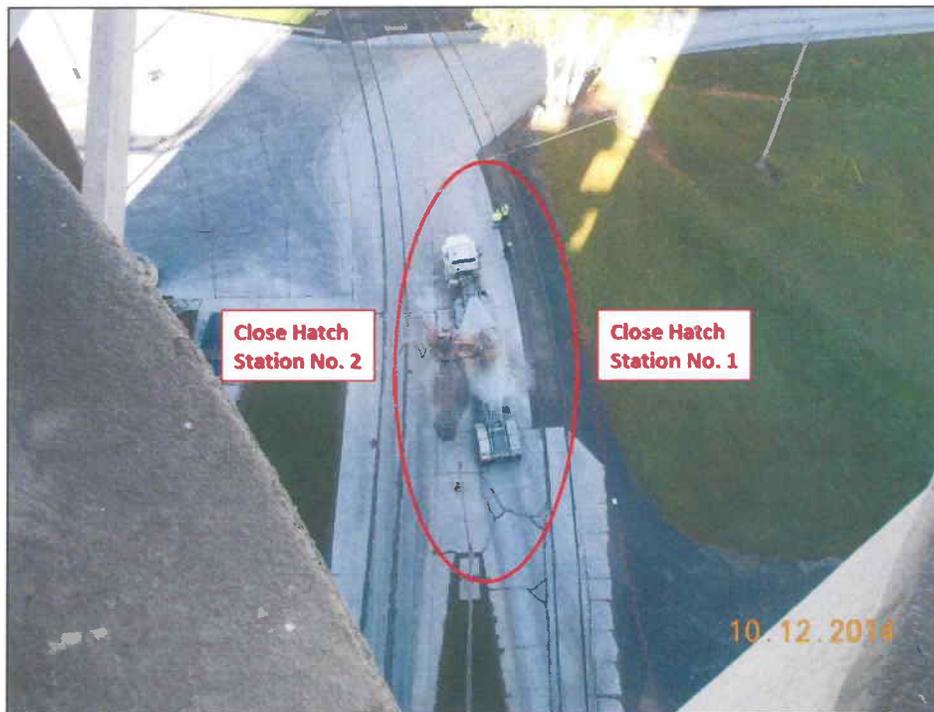
The accident occurred at close hatch station No. 1 (see Figure 2). Upon exiting the No. 1 side silos, the northern roadway curves with a 230-foot radius or 25-degree curve to the southwest. Close hatch station No. 1 is located to the southwest along the curved roadway, 85 feet from the silo exit doors. Trucks loaded at the No.1 side need to be driven laterally 15 feet to the south so the fill port of the bulk trailer is centered within the safety cage provided at the close hatch station. After the truck drivers close and fasten the hatches, the trucks exit the plant by making a 90 degree turn to the west approximately 55 feet from the close hatch station.

Since the front of each truck typically extends at least 20 feet beyond the close hatch station, there is only 35 feet of roadway left for the truck drivers to negotiate the 90 degree turn. Therefore, the truck drivers align their trucks in a southwest direction before parking at the close hatch station. Truck alignment in the southwest direction provides the truck drivers more room to negotiate the curve by increasing the turning radius and orienting the tractor at an angle with the trailer of approximately 150 degrees before entering the 90 degree turn. With the 150 degree angle between the tractor and trailer, the tractors can make the 90 degree turn while the trailers lag behind and fit diagonally at the entrance of the turn where the width of the roadway is 40 feet.

Figure 2 - Aerial View of accident site from top of adjacent silo showing alignment of bulk tanker truck.

Corrective Action: To ensure proper alignment of bulk tanker trucks, mine management installed cement barriers and painted delineating lines along the roadway leading to close hatch station No. 1. In addition, overhead cameras have been installed at close hatch stations No. 1 and No. 2, complete with video display monitors, to enable truck drivers to view the top hatch and properly position their trucks under the G4 SafeRack system. Multilingual warning signs have also been posted at the scale house and bulk load out station exits to warn truck drivers of the hazards associated with misalignment of bulk tanker trucks.

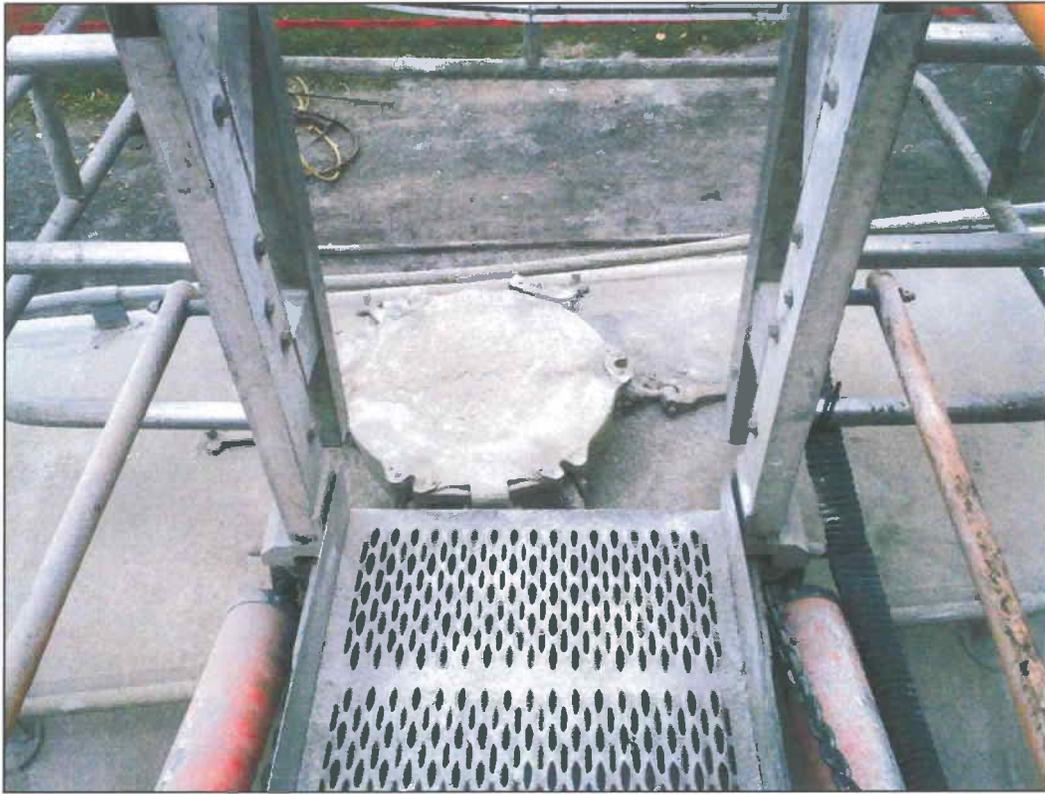
At the time of the accident, due to the position of the truck's trailer, the fill port on the trailer was not centered within the confines of the safety cage (see Figure 3). The dimensional offsets were one foot too close to the gangway at the south side and two feet too far forward to the west. The misalignment of the trailer caused three conditions that contributed to Laity's fall. These conditions were:

Figure 3 - Tanker truck found with hatch closed (Note: close proximity of hatch hinge to the gangway).

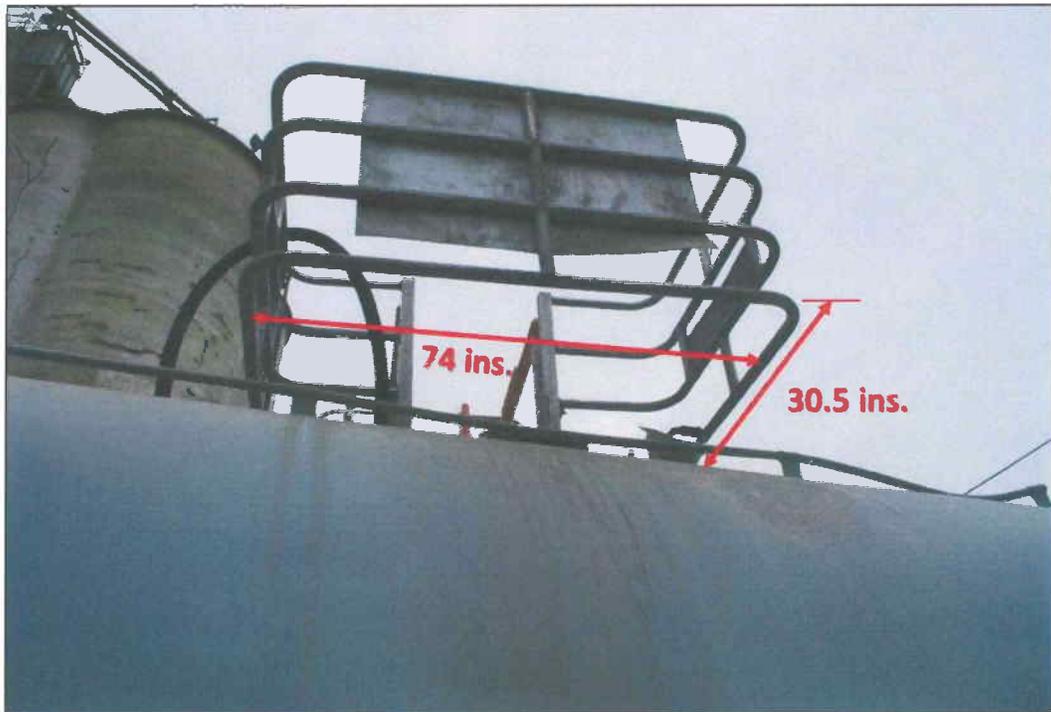
1. The safety cage had to be picked up manually in order to access and close the hatch of the fill port;
2. A large vertical separation between the top of trailer and the bottom of the cage existed (see Figure 4);
3. The area that Laity could position his feet to establish a stable base and stay clear of potential tripping hazards was reduced on the east end of the cage where he was standing before he tripped and fell to the ground below.

A fatal accident occurred at this mine on October 10, 2014. A contract truck driver (victim) positioned his tank trailer at an angle to the SafeRack system resulting in the safety cage not being centered over the middle tank hatch lid. This left a 30-inch opening between the top of the truck and the bottom rail of the SafeRack safety cage through which he fell 10 feet to the ground below. The mine operator did not provide warning signs at close hatch station No. 1 to identify the potential hazards associated with improper alignment of bulk tanker trucks.

Figure 4 - Open area between G4 SafeRack safety cage and top of bulk tanker truck.

Corrective Action: Contract management established a written policy and safe work procedures, including the use of fall protection when there is a danger of falling from performing work on top of bulk tanker trucks at the plant. All contract truck drivers were trained in these new policies and procedures.
