UNITED STATES  
DEPARTMENT OF LABOR  
MINE SAFETY AND HEALTH ADMINISTRATION  
Metal and Nonmetal Mine Safety and Health

REPORT OF INVESTIGATION

Fatal Powered Haulage Accident  
December 1, 2014

MGQ Aggregates Incorporated  
Millersville Quarry  
Helena, Sandusky County, Ohio  
Mine ID No. 33-04511

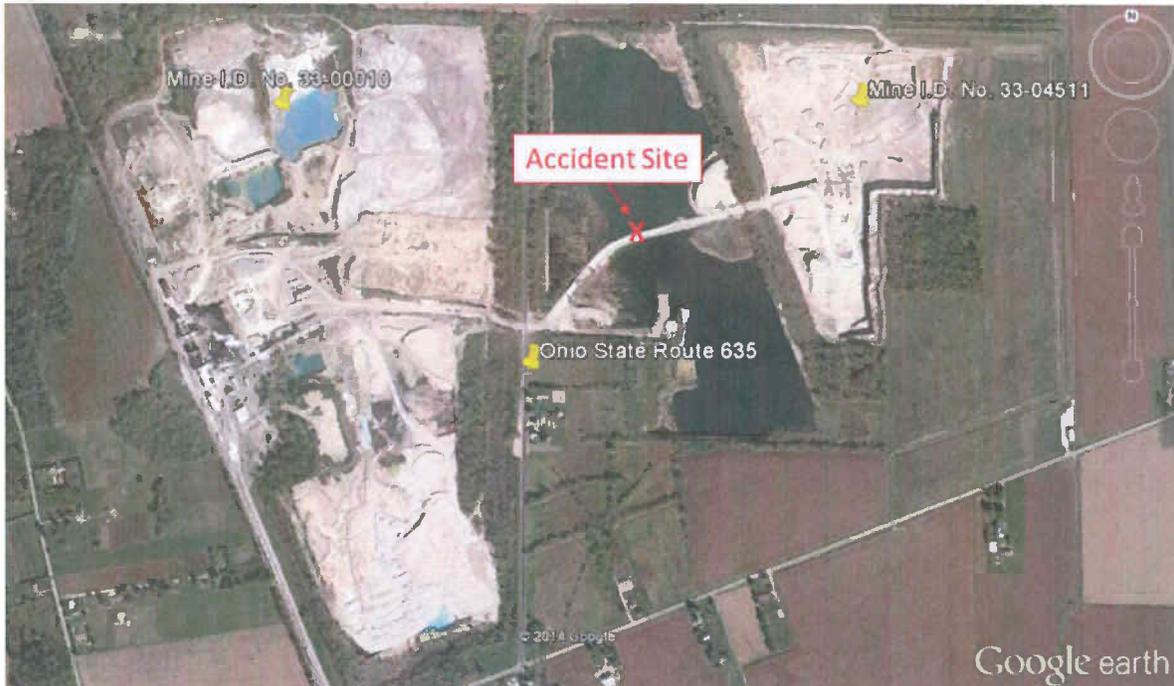
The accident occurred on the main quarry haul road approximately 960 feet from State Route 635 near a 36-degree curve to the south in the haul road. The victim's truck was traveling from west to east. Substantial berms are constructed on both sides along the length of the haul road. The haul road is smooth, consisting of hard-packed limestone, and is approximately 40 feet wide

The berms consist primarily of limestone rocks ranging in size from 3 inches to 8 inches. The berm height in the area where the truck ran over the berm is approximately 66 inches above the adjacent roadway with a base approximately 17 feet between the roadway and pond. Tire tracks on the berm indicate the left front tire impacted the berm at an angle of approximately 21 degrees. As the result of trucks traveling the road and periodic grading, fine limestone dust had accumulated over time between the base of the berms and the haul road. This created an approximately 30-inch wide and 16-inch high ramp up onto the berms.

Figure 1 – Aerial View of MGQ Aggregates Incorporated and Carmeuse Lime Inc. showing the Accident Site on the main quarry haulage road approximately 960 feet east of State Route 635.

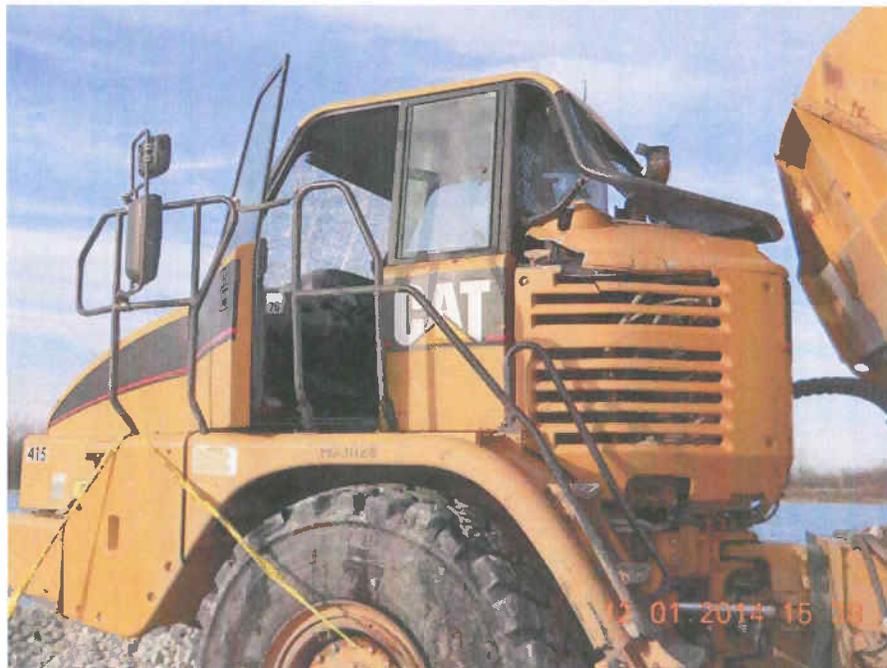
2. **Truck Conditions Found:** The truck sustained minor damage due to the accident. Water entered the engine, transmission, and hydraulic systems. The front windshield was broken and the fiberglass cowling behind the operator's compartment was cracked and had pieces broken off. The front skid plate was bent up and the adjacent engine exhaust pipe was bent in and had approximately a 3/8-inch hole in the pipe in this area.

Figure 2 – Photo of the Victim's Truck showing accident-related damage.
