**REPORT OF INVESTIGATION**

**Surface Nonmetal Mine  
(Phosphate Rock)**

**Fatal Machinery Accident  
January 26, 2015**

**PCS Phosphate – White Springs  
Swift Creek Mine  
Jasper, Hamilton County, Florida  
Mine ID No. 08-00798**

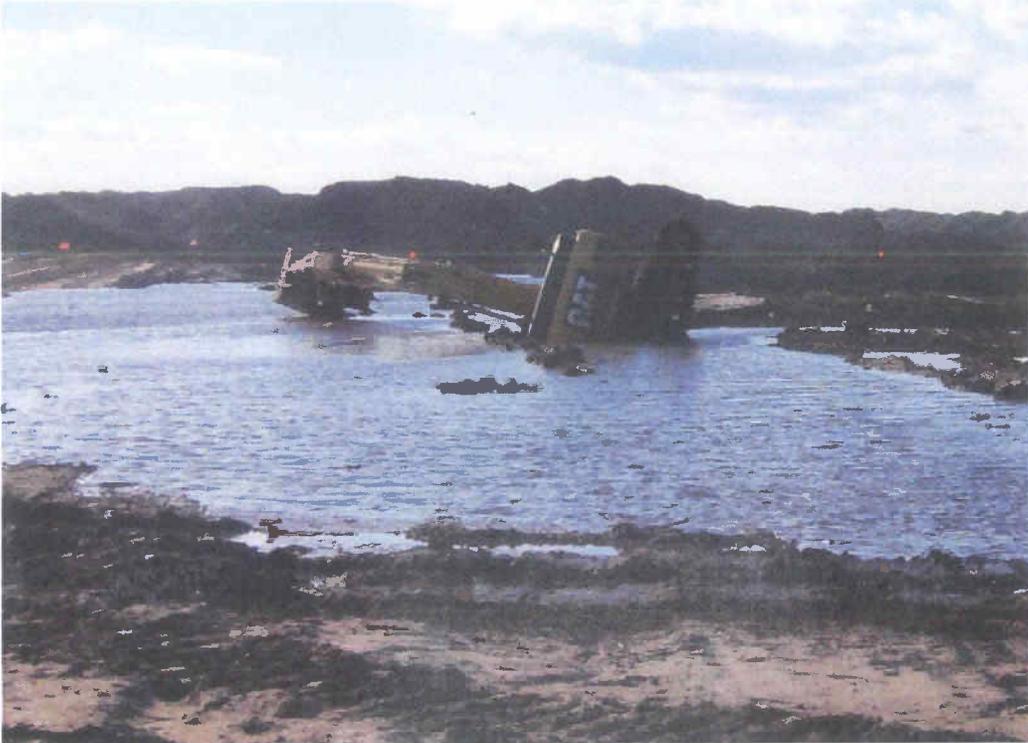
In the area of standing water, an old drainage ditch (the Old Hooker Bay Perimeter ditch) had been filled in and then recently partially re-excavated, leaving a closed end trench that had no drainage outlet for rainfall. The ditch measured approximately 15 feet wide and 6 to 7 feet deep. As the excavator moved forward, it tipped into this ditch with the cab pressing

against the far wall of the ditch. Illustration 1 shows the flooded area at the time of the accident, with the ditch not visible. Illustration 2 shows the area after water had been pumped out.

Illustration 1: Flooded area and partially submerged excavator

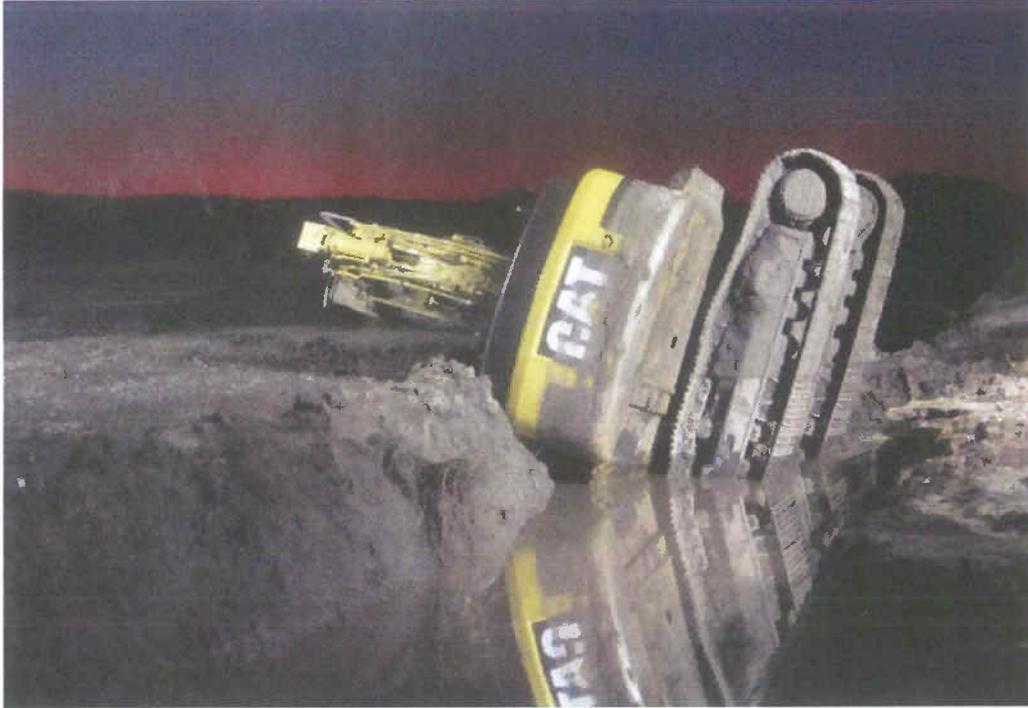
Illustration 2: Excavator and ditch with most of the water removed
