MAI-2016-01

REPORT OF INVESTIGATION

**Fatal Fall of Material Accident
February 26, 2016**

**Vista Sand
Lonestar Prospects Ltd.
Granbury, Texas
Mine ID No. 41-04430**

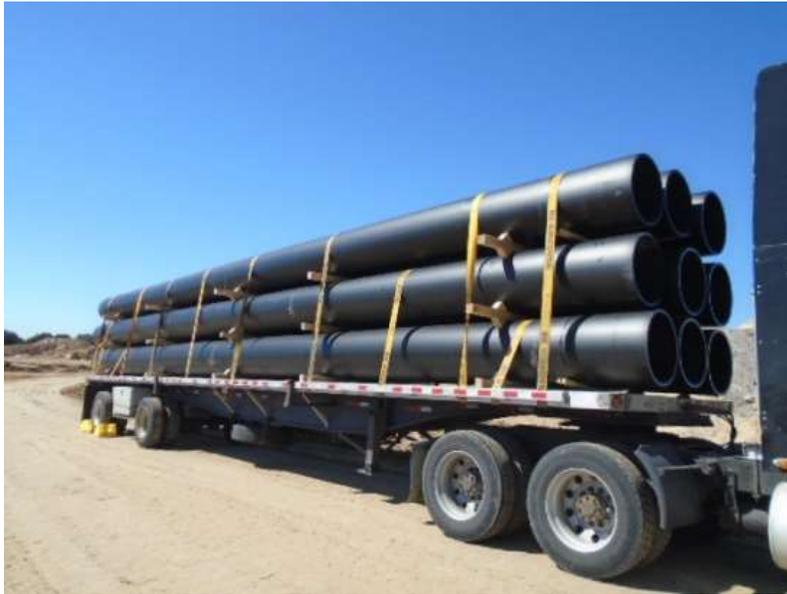
Attachment #1

At approximately 7:50 am, Terrell pulled his Volvo trailer truck into position at the unloading area. The trailer load of pipe consisted of nine pipe sections arranged in three rows of three sections each. Two pipe sections in each row were banded together by the manufacturer. Five, four by four wooden timbers were placed between each row of pipe to provide stabilization. There were chock blocks for 3 out of 5 timbers that were used to prevent the sections of pipe from rolling. The load of pipe was secured to the trailer with sixteen, four-inch wide, nylon ratchet straps. See attachment #1 for example
