**Fatality #8 - June 27, 2011**  
**Fall of Face/Rib - Underground - West Virginia**  
**Rhino Eastern LLC - Eagle #1**

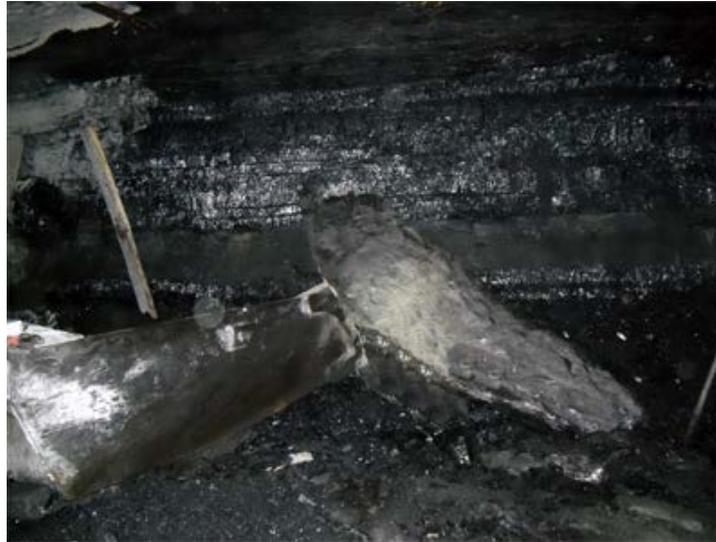
**COAL MINE FATALITY** - - On Monday, June 27, 2011, a 33 year old miner was killed when a portion of coal and rock fell from the upper portion of a pillar rib. The material that fell was approximately 8 feet long, by 32 inches thick, by 3 feet high.

- Conduct a thorough visual examination of the roof, face, and ribs immediately before any work or travel is started in an area and thereafter as conditions warrant.
- Perform careful examinations of pillar corners, particularly where the angles are formed between entries and crosscuts are less than 90 degrees.
- Support any loose rib or roof material adequately or scale before beginning work.
- Take additional safety precautions when mining heights increase to prevent development of rib hazards.
- In areas prone to deterioration, install rib support when the area is mined initially.
- Be alert to changing geologic conditions which may affect roof/rib conditions.
