## Coal Mine Fatal Accident 2005-19

Operator:	Rosebud Mining Company
Mine:	Logansport Mine
Accident Date:	December 12, 2005
Classification:	Roof Fall
Location:	Dist. 2, Armstrong County, PA
Mine Type:	Underground Coal Mine
Production	2,500 tons/day

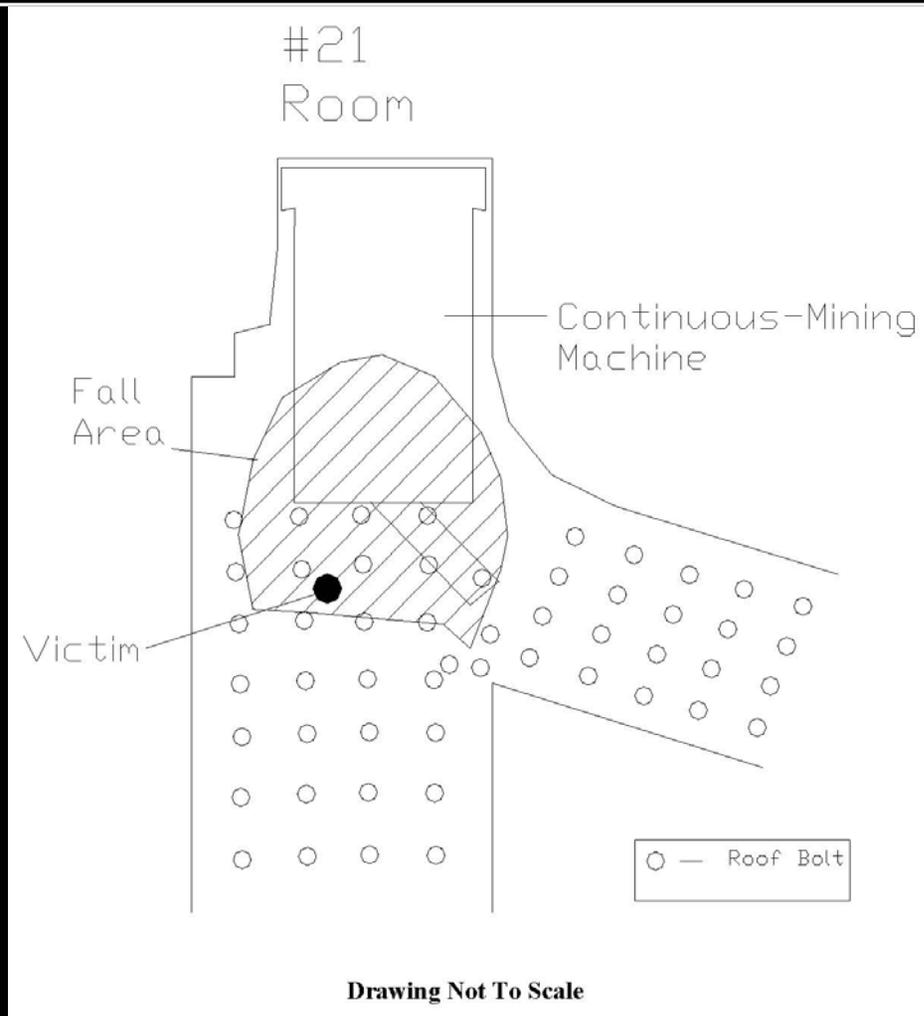
On December 12, 2005, the daylight shift crew, for 6th North Butt section traveled from the surface to the working section. The preshift examiner conducted the preshift examination and remained on the section due to adverse roof conditions.
