**Fatality #12 – October 7, 2014**  
**Fall of Highwall - Surface Mine - Kentucky**  
**Commonwealth Mining LLC; Tinsley Branch HWM 61**

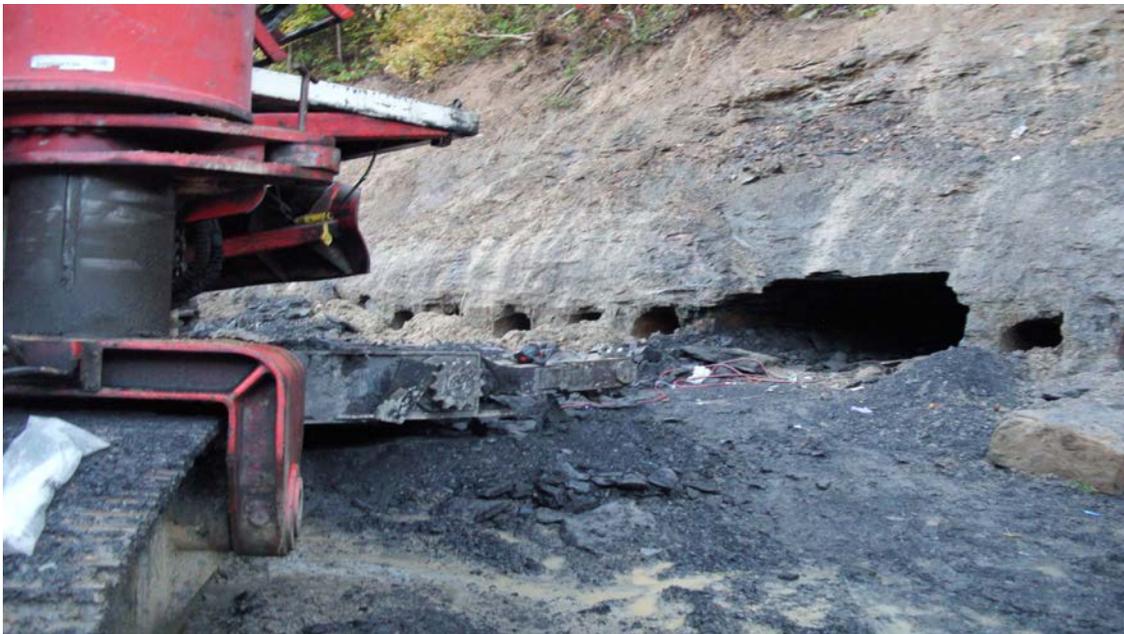
**COAL MINE FATALITY** - On Tuesday, October 7, 2014, a 31-year-old utility worker, with 13 years of mining experience, was killed after he crawled 37 feet into an entry mined with a highwall mining machine to retrieve a broken cutter-head-chain from the mining machine. A rock, 8 feet wide, 6 feet long, and 16 inches thick fell on him. He was initially transported to a local hospital and was being airlifted to a larger medical facility when he died.

- Never go under unsupported roof.
- Never enter a hole mined with a highwall mining machine or auger without a specific, detailed, and approved plan to do so.
- Develop a plan to remotely retrieve any part of a highwall mining machine caught or left in an entry. The plan must specify methods which do not expose miners to hazards. Train all personnel in such plans.
- Know and follow the provisions of the established Ground Control Plan.
- Establish Ground Control Plans for highwall mining operations that ensure safety and address web spacing, depth of penetration, and confined work areas.
- Keep all equipment in proper working order by establishing and implementing maintenance schedules.
